Fort Donelson National Battlefield

Accessibility Assessment

FINAL REPORT

Findings and Recommendations

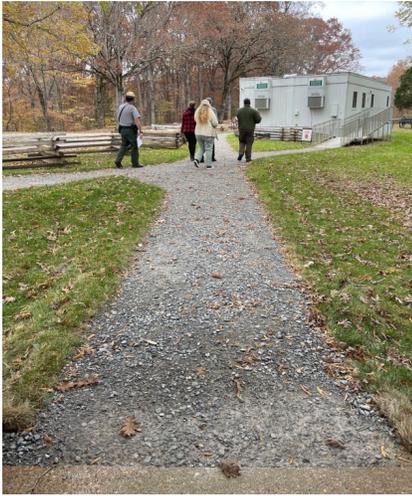
Location: Visitor Center Parking Lot

Missing proper parking space identification signs.

Corrective Action: Add accessible parking space signage
