Acadia National Park

Accessibility Assessment

FINAL REPORT
Findings and Recommendations
DECEMBER 2021

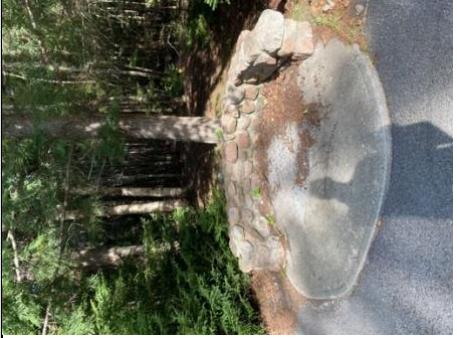
Location: Amphitheater Path Corrective Action: Ensure clear space around all operable sides of the firepit	Deficiency The firepit to stage right in the amphitheater does not have enough clear space around it.	Solution Ensure that there is 30x48 inches of clear space around all usable sides of the firepit to ensure someone who has mobility impairments can fully use the firepit.	Criticality Serious	Timeframe Short-term

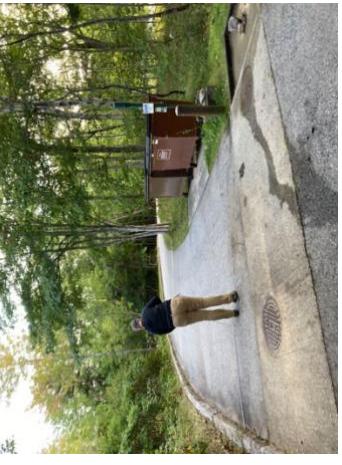
ACAD_KGP_172
Reference Standards and Guidelines: ABA 305						
Location: Dump Station Corrective Action: Widen road through the dump station	Deficiency The road at the dump site is too narrow (15.5 ft wide).	Solution Widen the road to at least 20 ft to accommodate a vehicle and the necessary clear space required to move around the vehicle.	Criticality Serious	Timeframe Short-term

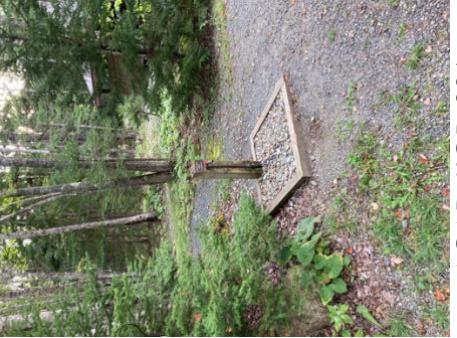
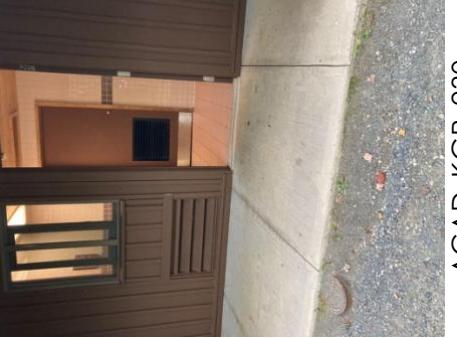
Location: Throughout Campground Corrective Action: Redesign water spigots					
<u>Deficiency</u> The water spigots throughout the campground are not accessible.	<u>Solution</u> Redesign the water spigots to ensure there is a minimum of 72x48 inches of clear ground space (with the long side of the space adjoining or overlapping the pull-up space for campers). The clear ground space must be located so that the waterspout is between 11 and 12 inches from the rear center of the long side of the space. This allows people using mobility devices to approach and operate the waterspout from either the right or left side.	<u>Criticality</u> Serious	<u>Timeframe</u> Short-term

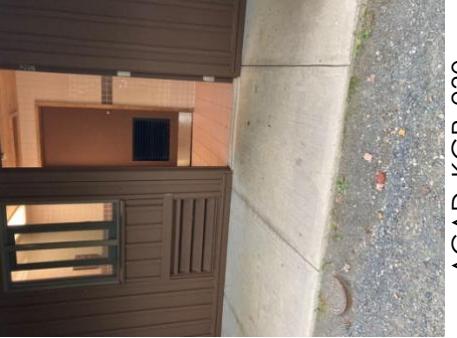
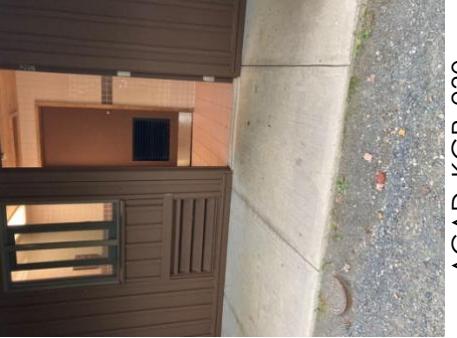
Reference Standards and Guidelines: ABA 1011.2, 1011.3, 1011.6					
Location: Restroom and Indoor Washing Stations Corrective Action: Ensure an accessible route to the restroom and indoor washing station					
<u>Deficiency</u> There is a large change in surface level from the ground to the bathroom and washing stations.	<u>Solution</u> Ensure there is an accessible route or an ORAR to all restrooms and inside washing stations that is stable and firm with a running slope $<1:20$, a cross slope $<1:48$, openings $<\frac{1}{2}$ inch, changes in level $<\frac{1}{4}$ inch, and a width of >36 inches as well as with 30x48 inches of clear ground space.	<u>Criticality</u> Critical	<u>Timeframe</u> Short-term

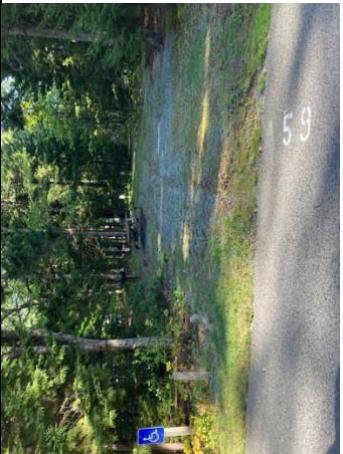
Location: Accessible Campsites Corrective Action: Add firm, stable ground material	<u>Deficiency</u> The ground of the accessible campsites is not firm or stable.	<u>Solution</u> Resurface ground of accessible campsites with material that is firm and stable. Recommend using ground material like that used on the carriage roads.	<u>Criticality</u> Critical	<u>Timeframe</u> Short-term

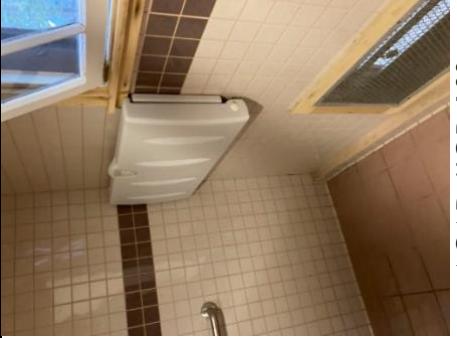
Location: Restrooms			
Corrective Action: Move all features within the restroom to be within reach range			
<u>Deficiency</u>	<u>Solution</u>	<u>Criticality</u>	<u>Timeframe</u>
The features within the restrooms are inconsistently positioned within reach range for all individuals.	Ensure the operable parts of all soap dispensers, hooks, outlets, changing stations, and shelves are positioned at a maximum of 48 inches above the ground and are not blocked by other objects either on the wall or on the ground.	Serious	Immediate

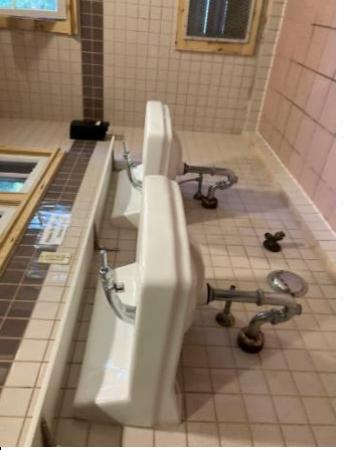
ACAD_KGP_183			
Reference Standards and Guidelines: ABA 308			
Location: Restrooms			
Corrective Action: Wrap all exposed pipes under the sinks.			
<u>Deficiency</u>	<u>Solution</u>	<u>Criticality</u>	<u>Timeframe</u>
The pipes are exposed under the sinks causing a safety risk.	Ensure all the pipes underneath the sinks are wrapped/insulated to avoid injury from sharp edges or hot/cold temperatures.	Critical	Immediate

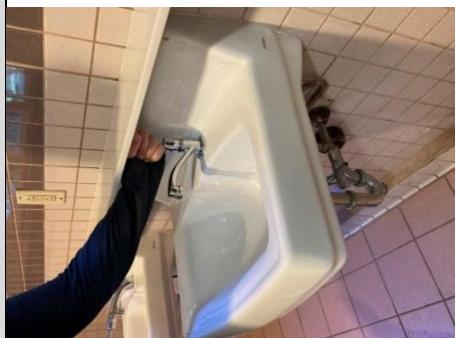
Location: Restrooms Corrective Action: Increase the time the faucets are open to at least 10 sec.	Deficiency The hand-operated metering faucets do not stay on long enough. Solution Ensure the hand-operated metering faucets shall remain open for 10 seconds minimum for individuals to be able to wash their hands successfully. Ensure the hand-operated faucets are not blocked by the countertop above the sinks.	<u>Criticality</u> Critical <u>Timeframe</u> Immediate

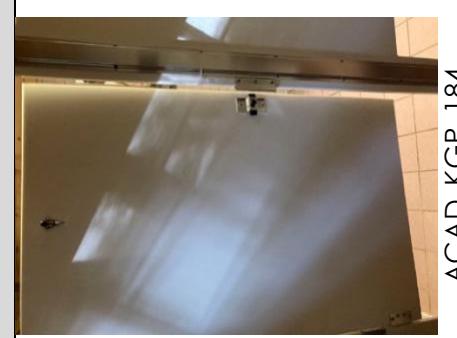
ACAD_KGP_196
Location: Restrooms Corrective Action: Add D-rings to the inside doors of the accessible stalls	Deficiency The accessible stall doors are difficult to close for people with impaired hand function. Solution Add D-rings to the inside door of the accessible stalls to facilitate door closing for people with impaired hand function.	<u>Criticality</u> Serious <u>Timeframe</u> Immediate

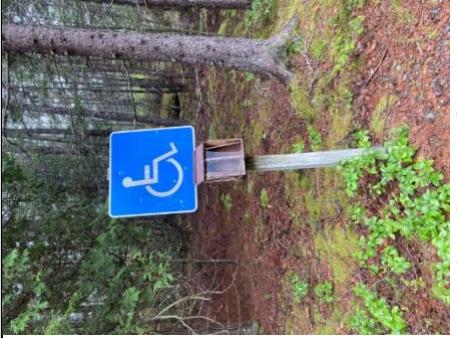
Location: Parking Lot Corrective Action: Replace parking lot ground material and stripe parking spaces	
<p><u>Deficiency</u> The parking lot where the accessible parking spaces are located does not have a firm, stable surface and it is not lined.</p> <p><u>Solution</u> Replace parking lot closest to the site with a ground material that is firm, stable, and slip resistant.</p> <p>Line the accessible parking lot with at least two van-accessible parking spaces. These spaces should be a minimum of 132" wide with an access aisle of a minimum of 60" wide or a parking space 96" wide minimum where the access aisle is 96" wide minimum.</p>	<p>Criticality Critical</p> <p>Timeframe Short-term</p>

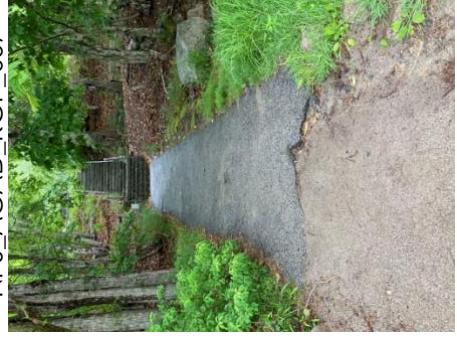
Location: Echo Lake Beach - Path from stairs to boardwalk Corrective Action: Replace path to decrease gaps in materials

NPS_ACAD_KGP_067	NPS_ACAD_KGP_066
<u>Deficiency</u>	<u>Solution</u>	Criticality	Timeframe		
The transitions from pavement to sand and sand to boardwalk at the bottom of the steps are too large (>1inch, >3inches).	Extend the boardwalk laterally to the bottom of the steps or replace the sand with ground material extending from the pavement to the boardwalk that is stable, firm, and slip resistant and ensures no gaps between materials.	Serious	Immediate

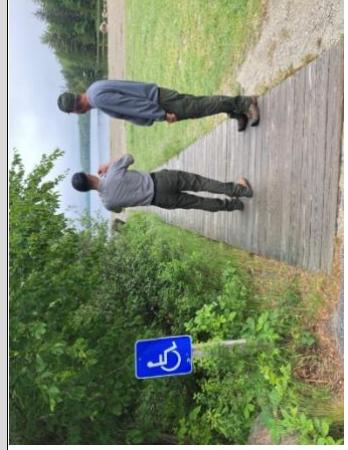
Reference Standards and Guidelines: ABA 302.3, 403				
Location: Echo Lake Beach - Parking Lot Corrective Action: Add two signs marking the accessible route down to the beach				
<u>Deficiency</u> There is no sign indicating the accessible route from the parking lot to the beach. The sign indicating the accessible route is at the bottom of the paved path at the start of the boardwalk.	<u>Solution</u> Add a sign at the parking lot in front of the stairway directing the public to the accessible route. Add a sign in front of the paved route down to the beach indicating the accessible route.	<u>Criticality</u> Serious	<u>Timeframe</u> Immediate	NPS_ACAD_KGP_073

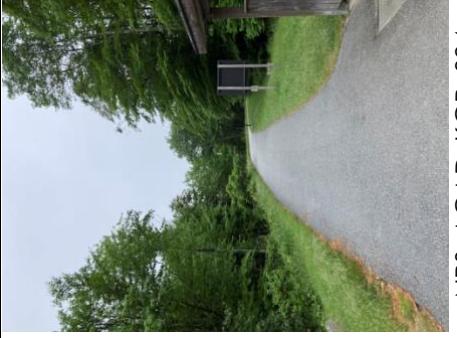
Location: Echo Lake Beach - Paved Path Corrective Action: Decrease slope to <5% grade	<u>Deficiency</u> The paved trail down to Echo Beach has maximum slope grades of 5.4-5.8% with a 2.5% cross slope. <u>Solution</u> Ensure paved path has a grade of <5% when the path requires to be repaved.	<u>Criticality</u> Minor <u>Timeframe</u> Long -term

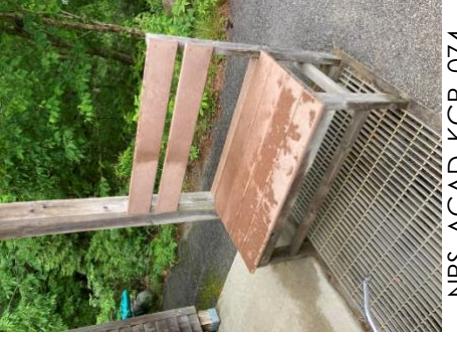
NPS_ACAD_KGP_094
Reference Standards and Guidelines: ABA 403.3			Location: Echo Lake Beach Corrective Action: Replace current grating under washing station
<u>Deficiency</u> The grates underneath the two foot-washing stations have openings that are too large (4.5 inches x 1inches).	<u>Solution</u> Replace current grates with grates that have openings of <½ inch x ½ inch.	<u>Criticality</u> Serious <u>Timeframe</u> Short-term

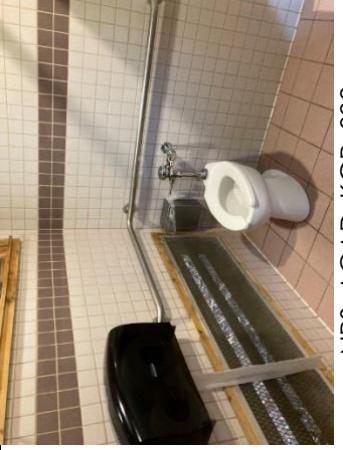
<u>Deficiency</u> The sanitary basket is behind the toilet, out of reach range.	Move the sanitary basket to the open side of the toilet so that individuals do not have to reach across the toilet bowl to access the sanitary basket.
The grab bars are not oriented correctly. (CONTINUED)

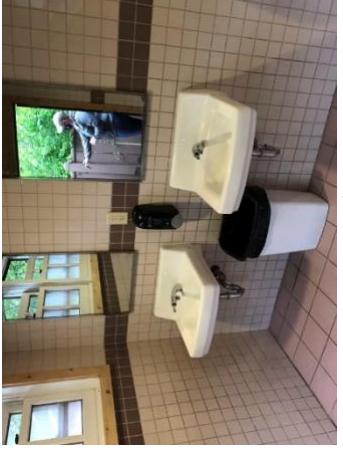
<p>Location: Family, Men's, Women's restroom Corrective Action: Wrap pipes under sink</p>	<p>Deficiency The pipes are exposed underneath the sink.</p> <p>Solution Wrap the pipes under the sinks in the Restrooms to prevent injury from hot/cold and sharp edges for someone who uses a wheelchair and positions their legs under the sink while washing their hands.</p>	<p>Criticality Critical</p> <p>Timeframe Immediate</p>

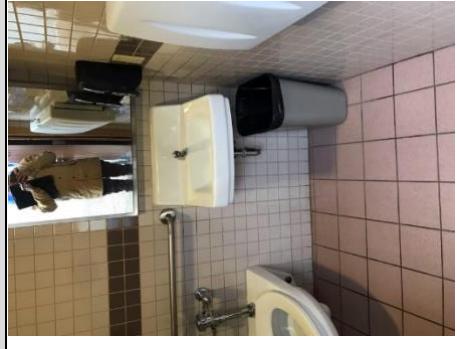
ACAD_Fabbri_LMK_088
<p>Reference Standards and Guidelines: ABBAS 606.5</p>				
<p>Location: Women's, Men's, Family Restrooms Corrective Action: Lower mirrors and hooks</p>	<p>Deficiency The mirrors and clothing hooks are all too high.</p> <p>Solution Mirrors located above countertops shall be installed with the bottom edge of the reflecting surface 40" maximum from the floor. Lower hooks to be <48 within reach range.</p>	<p>Criticality Serious</p> <p>Timeframe Immediate</p>

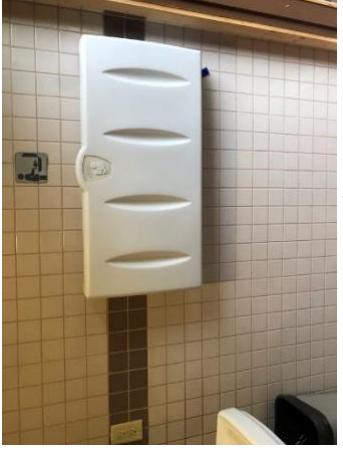
Location: Family Restroom Corrective Action: Lower baby changing station		<u>Solution</u> Lower the baby changing station so that the height of the opening mechanism is <48" to be within reach range.	
<u>Deficiency</u>	The baby changing station is too high outside of reach range.	<u>Criticality</u>	Serious
Reference Standards and Guidelines: ABBAS 308.2.1			
Location: Family Restroom Corrective Action: Replace toilet		<u>Solution</u> Replace the toilet with one that has the flush control on the open side of the toilet to be within reach range, so individuals may be able to flush. Toilet seat height should be 17-19" to comply with accessibility standards.	
<u>Deficiency</u>	The flusher is on the wrong side of the toilet.	<u>Criticality</u>	Serious
Reference Standards and Guidelines: ABBAS 604.6, 604.4

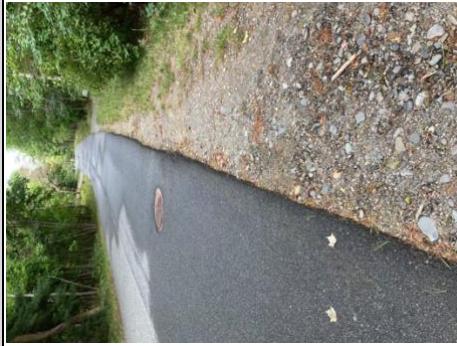
Location: Great Meadow Loop Corrective Action: Improve surface material of trail		Criticality Serious	Timeframe Short-term
Deficiency	Solution		
Loose surface material is used in sections of trail	The surfaces of trails, passing spaces, and resting intervals must be firm and stable. Paving with concrete or asphalt may be appropriate for highly developed areas. For less developed areas, crushed stone, fine crusher rejects, packed soil, soil stabilizers, and other natural materials may provide a firm and stable surface. Natural materials also can be combined with synthetic bonding materials to provide greater stability and firmness.		
Reference Standards and Guidelines: ABBAS 1017.2			ACAD_Grt Meadow Loop_KGO_303

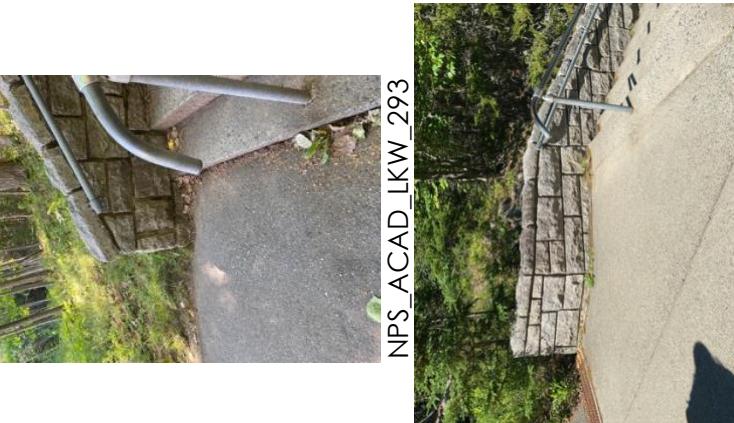
Location: Route from parking to visitor center - stairs Corrective Action: Replace handrails		<u>Criticality</u>	
Deficiency Handrails on the stairs leading to the visitor center are open on the ends and could catch loose clothing or accessories. This poses a hazard, particularly for people who are unsteady on their feet.	Solution Replace the handrails with continuous, closed rails that extend 12 inches beyond the top and bottom of each flight and meet ADA standards for height and dimensions.	Critical Timeframe Short-term

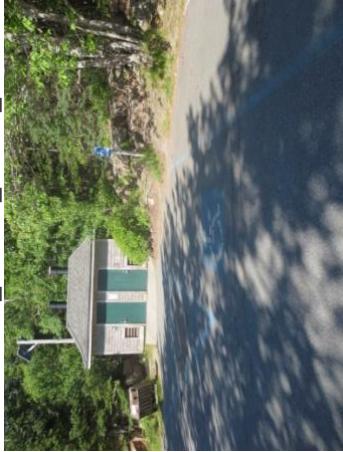
NPS_ACAD_LMNK_	NPS_ACAD_MEC_102
<u>Deficiency</u>	<u>Solution</u>				
Accessible parking spaces are not properly marked for angled parking. Some van accessible spaces do not have an access aisle on the passenger side, which is required for angled spaces.	Maintain angled parking and add access aisles as required. Ensure that aisle is met by a curb cut at the sidewalk. Recommend adding appropriate signage raising the sign marking the van accessible parking space to >60".

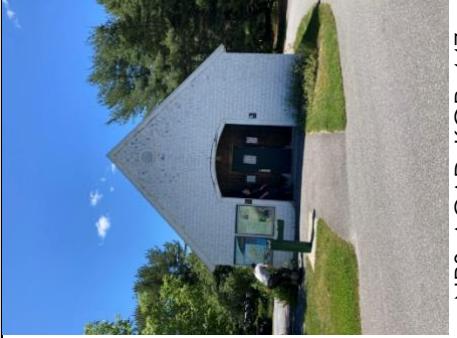
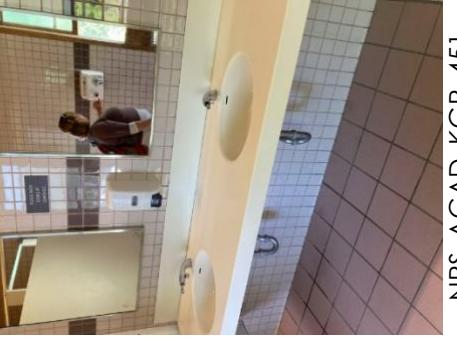
<small>NPS_ACAD_KGP_447</small>					
Reference Standards and Guidelines: ABAAS 303, 405.2					
Location: Men's and Women's Restrooms Corrective Action: Wrap pipes under sinks.					
<u>Deficiency</u> The pipes are exposed underneath the sink.	<u>Solution</u> Wrap the pipes under the sinks in the Men's and Women's Restrooms to prevent injury from hot/cold and sharp edges for someone who uses a wheelchair and positions their legs under the sink while washing their hands.	<u>Criticality</u> Critical	<u>Timeframe</u> Immediate
