Lincoln Home National Historic Site

Accessibility Assessment

FINAL REPORT

Findings and Recommendations

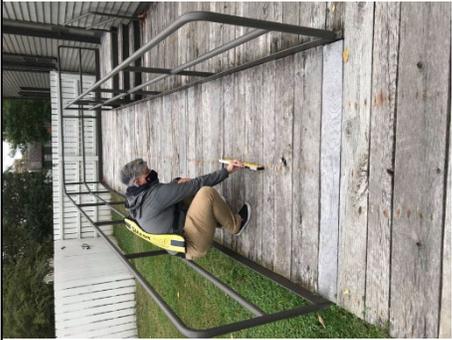
<p>Location: Accessible ramp Corrective Action: Replace handrail</p>			
<p><u>Deficiency</u> The handrails on the ramp do not extend far enough.</p>	<p><u>Solution</u> Replace the handrails on the ramp so that they extend 12" minimum beyond the top and bottom of ramp run.</p>	<p><u>Criticality</u> Serious</p> <p><u>Timeframe</u> Short-term</p>

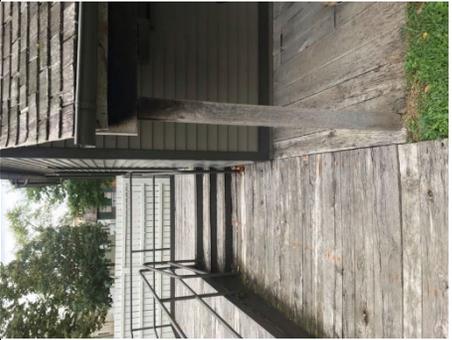
<p>LIHO_Arnold House_LMK_006</p>
<p>Reference Standards and Guidelines: ABAAS 505.10.2, 505.10.3</p>

<p>LIHO_Arnold House_LMK_002</p>
<p>Reference Standards and Guidelines: ABAAS 505.10.1</p>			
<p>Location: Accessible entrance stairs Corrective Action: Replace handrails</p>			
<p><u>Deficiency</u> The handrails for the stairs do not extend far enough.</p>	<p><u>Solution</u> Replace the handrails for the stairs so that they extend 12" minimum at the top and extend the length of one tread beyond the last riser nosing.</p>	<p><u>Criticality</u> Serious</p> <p><u>Timeframe</u> Short-term</p>

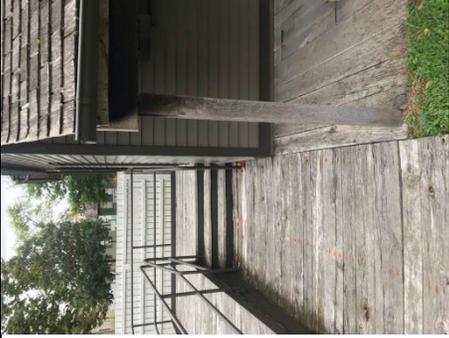
<p>Location: Accessible entrance stairs Corrective Action: Rebuild stairs</p>			
<p><u>Deficiency</u> Current stairs do not have curved or beveled nosings.</p>	<p><u>Solution</u> Rebuild the stairs so that the nosings are curved or beveled and project no more than 1.5" over the tread below.</p>	<p><u>Criticality</u> Minor</p> <p><u>Timeframe</u> Short-term</p>

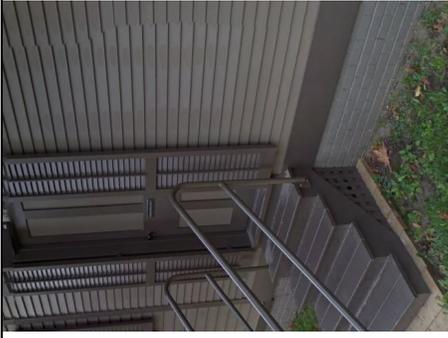
<p>LIHO_Arnold House_LMK_022</p>
<p>Reference Standards and Guidelines: ABAAS 405.2</p>

<p>LIHO_Arnold House_LMK_006</p>
<p>Reference Standards and Guidelines: ABAAS 504.5</p>			
<p>Location: Main entrance stairs Corrective Action: Replace handrails</p>			
<p><u>Deficiency</u> The handrails do not extend far enough.</p>	<p><u>Solution</u> Replace the handrails for the stairs at the front entrance so they extend 12" at the top.</p>	<p><u>Criticality</u> Serious</p> <p><u>Timeframe</u> Short-term</p>

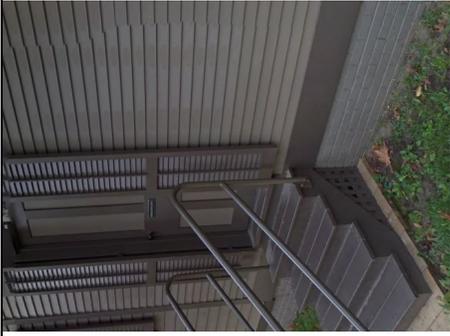
<p>Location: Main entrance stairs Corrective Action: Rebuild stairs</p>			
<p><u>Deficiency</u> Current stairs do not have curved or beveled nosings.</p>	<p><u>Solution</u> Rebuild the stairs so that the nosings are curved or beveled and project no more than 1.5" over the tread below.</p>	<p><u>Criticality</u> Minor</p> <p><u>Timeframe</u> Short-term</p>

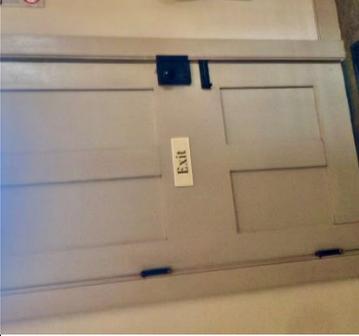
<p>LIHO_Arnold House_LMK_023</p>

<p>LIHO_Arnold House_LMK_002</p>
<p>Reference Standards and Guidelines: ABBAS 504.5</p>			
<p>Location: Arnold House main entrance Corrective Action: Replace doorknobs</p>			
<p><u>Deficiency</u> The doorknobs do not meet accessibility standards as they require tight grasping and twisting of the wrist.</p>	<p><u>Solution</u> Replace the doorknobs with lever-shaped handles that do not require tight grasping, pinching, or twisting of the wrist.</p>	<p><u>Criticality</u> Minor</p> <p><u>Timeframe</u> Short-term</p>

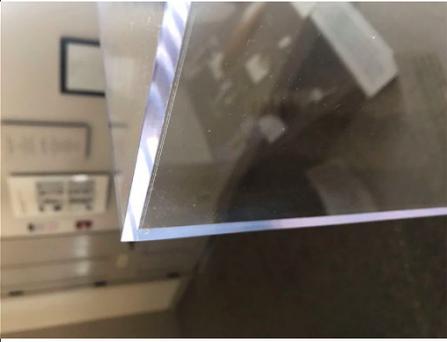
<p>LIHO_Arnold House_LMK_013</p>

<p>Location: Arnold House exhibits Corrective Action: Smooth sharp edges</p>			
<p><u>Deficiency</u> Clear plexiglass displays with sharp edges are particularly hazardous for people with low vision.</p>	<p><u>Solution</u> Bevel and smooth edges of the plexiglass display cases. Marking the edges with colored tape can also improve their visibility and prevent injury.</p>	<p><u>Criticality</u> Serious</p> <p><u>Timeframe</u> Short-term</p>

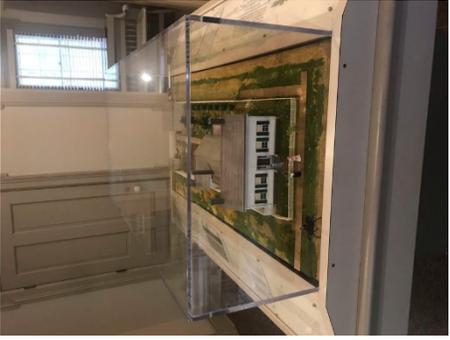
<p>Location: Exhibit display cases Corrective Action: Remove sharp edges</p>			
<p><u>Deficiency</u> Clear plexiglass displays with sharp edges are particularly hazardous for people with low-vision.</p>	<p><u>Solution</u> Replace display cases with cases that have rounded edges or bevel and smooth the edges to avoid potential injury to visitors who have limited vision and may lean forward to get a closer look at exhibits. Marking the corners with colored tape could also improve their visibility and prevent injury.</p>	<p><u>Criticality</u> Serious</p> <p><u>Timeframe</u> Short-term</p>

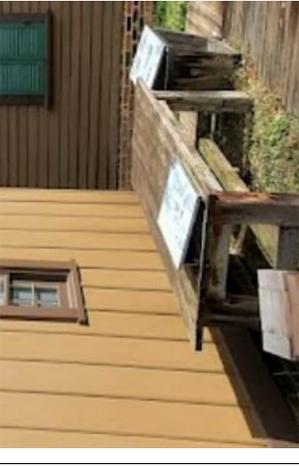
<p style="text-align: right;">LIHO_Dean House_LMK_045</p>
--	--	--	---

<p><u>Deficiency</u> The wayside is currently angled approximately 10 degrees and is not easily viewable by individuals using wheelchairs.</p>	<p><u>Solution</u> Increase the degree of the angle so the wayside is easy viewable by individuals using wheelchair or redesign the base of the wayside to be a standard low-profile NPS wayside with an angle of 30-45 degrees.</p>	<p><u>Criticality</u> Serious</p> <p><u>Timeframe</u> Short-term</p>

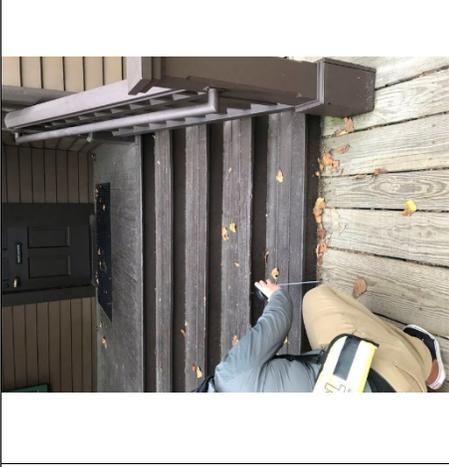
<p style="text-align: right;">LIHO_Dean House_LMK_052</p>
--	---	--	--

<p><u>Deficiency</u> The current stairs do not have uniform riser height or curved or beveled nosings.</p>	<p><u>Solution</u> Rebuild the stairs with uniform risers that are 4" minimum and 7" maximum high. Ensure that any nosings are either curved or beveled and project no more than 1.5" over the tread below.</p>	<p><u>Criticality</u> Serious</p> <p><u>Timeframe</u> Mid-term</p>

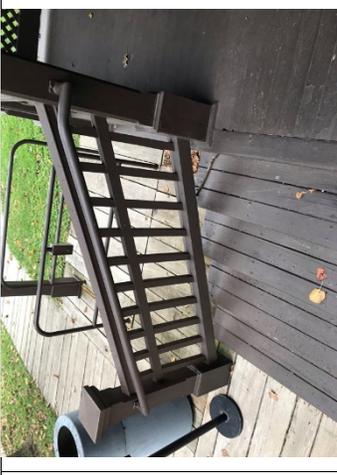
<p>LIHO_Dean House_LMK_054</p>
<p>Reference Standards and Guidelines: ABBAS 505.4, 505.10</p>

<p><u>Deficiency</u> The handrails are too low at 30.5" and do not extend far enough at the top of bottom.</p>	<p><u>Solution</u> Replace handrails so the top of the gripping surface is 34-38" above the stair nosing. Handrails should extend 12" at the top and 13" (the tread depth) at the bottom.</p>	<p><u>Criticality</u> Serious</p> <p><u>Timeframe</u> Short-term</p>

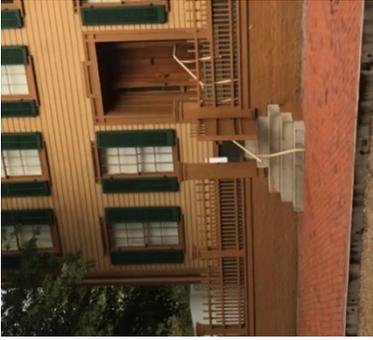
<p>Location: Lincoln Home exterior Corrective Action: Replace handrails</p>		
<p><u>Deficiency</u> The front steps only have a handrail on one side. The handrail does not return and does not extend far enough.</p>	<p><u>Solution</u> Replace the handrail with one that extends horizontally above the landing for 12" and returns to a wall, guard, or landing surface. The bottom of the handrail should extend at the slope of the stair flight for a horizontal distance equal to at least one tread depth beyond the last rider nosing.</p>	<p><u>Criticality</u> Serious</p> <p><u>Timeframe</u> Short-term</p>

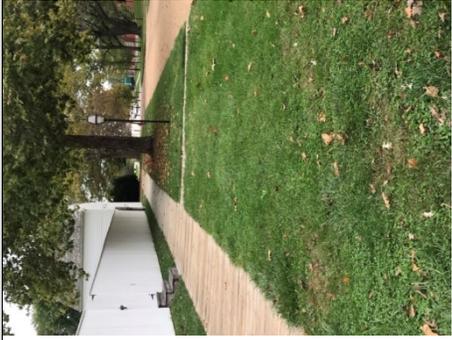
<p>LIHO_Lincoln Home_LMK_100</p>
<p>Reference Standards and Guidelines: ABAAS 505.1, 505.2, 505.10</p>

<p>Location: Lincoln Home side exit Corrective Action: Add handrails</p>			
<p><u>Deficiency</u> The steps leading from the side of the house to the boardwalk do not have handrails.</p>	<p><u>Solution</u> Install handrails on both sides of steps that extend horizontally above the landing for 12" and returns to a wall, guard, or landing surface. The bottom of the handrail should extend at the slope of the stair flight for a horizontal distance equal to at least one tread depth beyond the last riser nosing and return to a wall, guard, or landing surface.</p>	<p><u>Criticality</u> Serious</p> <p><u>Timeframe</u> Short-term</p>

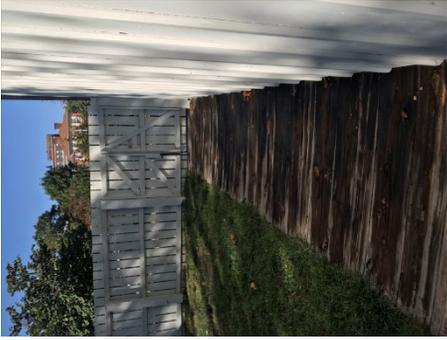
<p>Location: Corneau House Corrective Action: Widen entry gate</p>			
<p><u>Deficiency</u> The staff entry gate at the back of the house is too narrow at 26.5".</p>	<p><u>Solution</u> Replace the gate with one that provides a minimum clear width of 32".</p>	<p><u>Criticality</u> Serious</p> <p><u>Timeframe</u> Short-term</p>
