Fort Donelson National Battlefield

Accessibility Assessment

FINAL REPORT

Findings and Recommendations

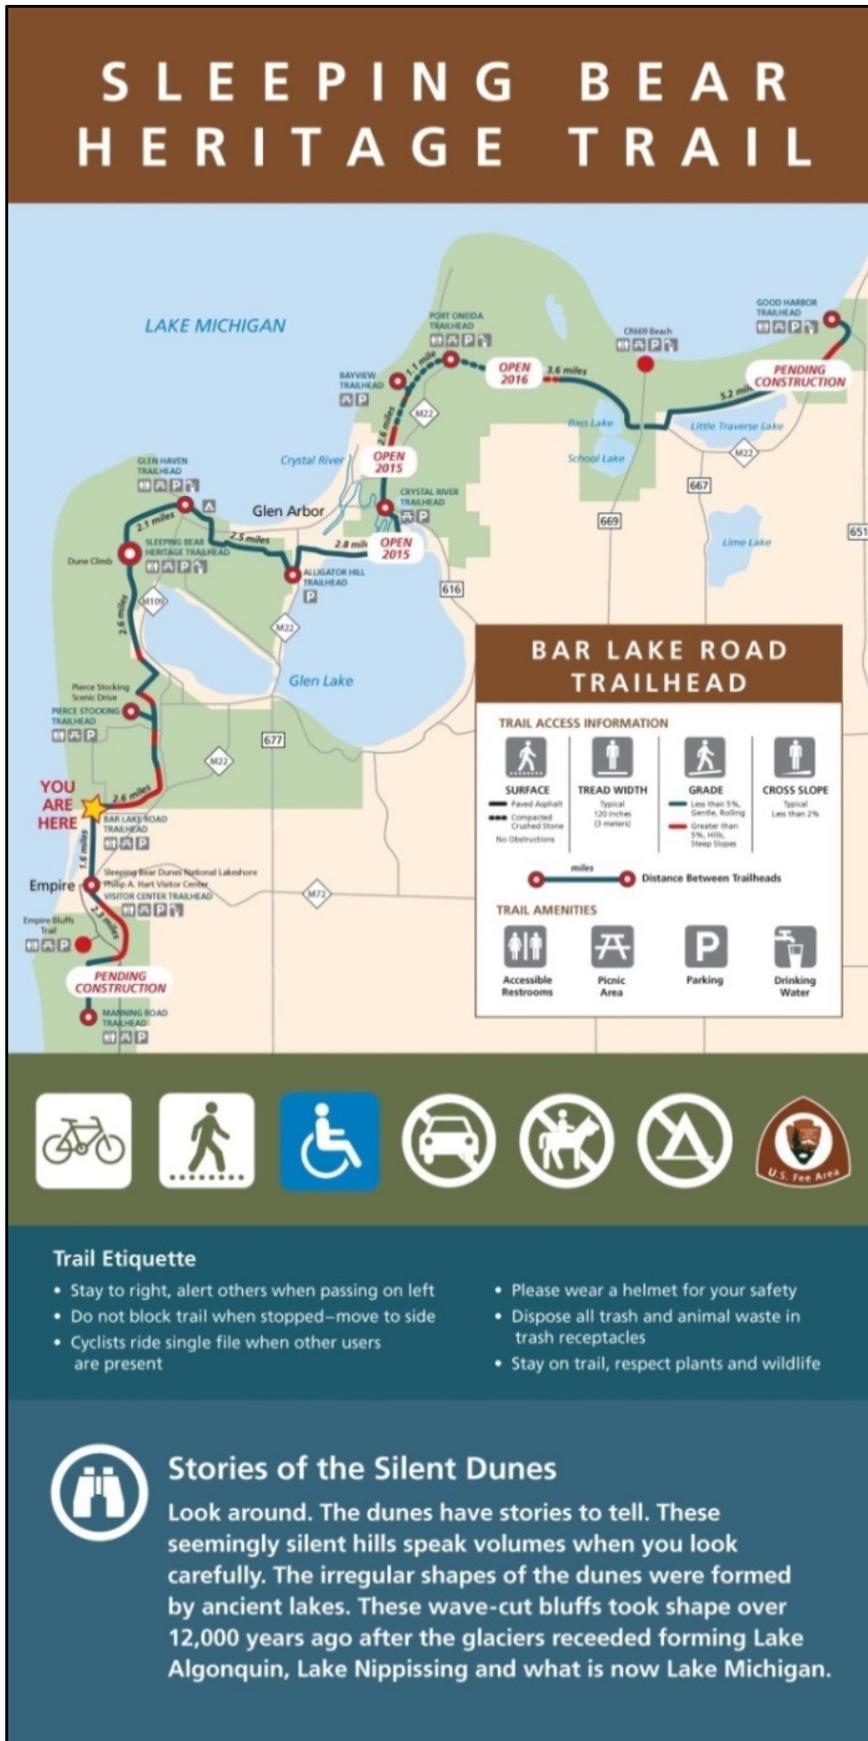
FIGURE 8. SLBD trailhead panel prototype, Sleeping Bear Dunes National Lakeshore

This map combines both interpretation and information in a single panel and map. Because of the area and shape of the site, trail data fit nicely within the landmass outside of the park. This design was a prototype. Some revisions could include the use of upper and lower case instead of all caps and a different approach to the red/green combination used on the trail itself.
