Acadia National Park

Accessibility Assessment

FINAL REPORT
Findings and Recommendations
DECEMBER 2021

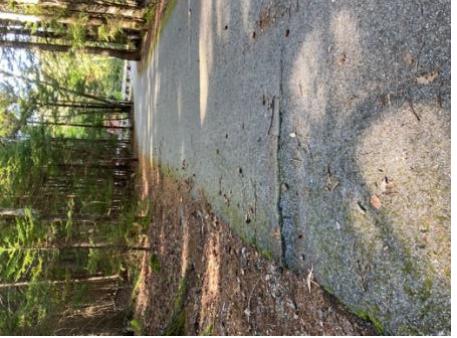
Location: Amphitheater Path Corrective Action: Repave path		<u>Solution</u> Repave the path to meet standards of an accessible route including a stable, firm, and slip resistant surface and with running slope <1:20, a cross slope <1:48, openings <½ inch, changes in level <¼ inch, and a width of >36 inches.		<u>Criticality</u> Serious	<u>Timeframe</u> Short-term

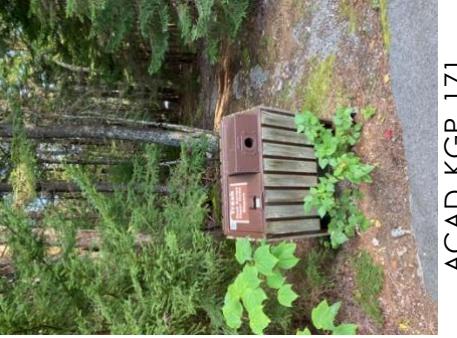
ACAD_KGP_171
Reference Standards and Guidelines: ABA 308

ACAD_KGP_160
Reference Standards and Guidelines: ABA 402, 403							
Location: Amphitheater Path Corrective Action: Bring the trash receptacle closer to the path		<u>Solution</u> Move the trash receptacle closer to the paved path to be within reach range for someone who has to stay on the paved path due to mobility impairments.		<u>Criticality</u> Serious	<u>Timeframe</u> Immediate

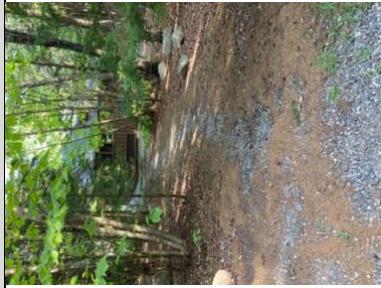
ACAD_KGP_177

Location: Campground paths Corrective Action: Reconstruct paths to adhere to ORAR standards			
<u>Deficiency</u>	<u>Solution</u>	<u>Criticality</u>	<u>Timeframe</u>
The ground of the campground paths is not firm or stable.	Ensure paths between campground features (including between campsites and the restrooms and between the road and the restrooms) meet the Outdoor Recreation Access Route standards including a firm, stable ground surface, 36 inches minimum width, passing spaces every 200 ft when the width is <60 inches, obstacles <1inch high, openings <1/2 inches wide, a running slope of 5% maximum or up to 10% if segment is short and resting intervals are provided, and a cross slope <5%. These requirements are in reference to paths that have a surface material other than concrete, asphalt, or boards. Recommend using the same ground material as the campsites, like that used on the carriage roads.	Critical	Short-term

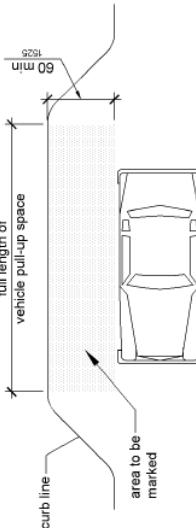
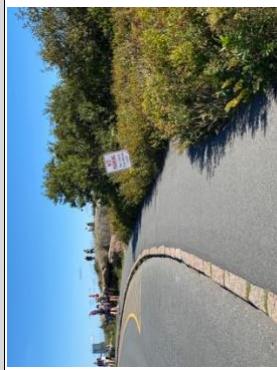
Location: Lower Summit Parking Lot - Bus Parking and Taxi Stand Corrective Action: Add passenger loading zones		
<p>Deficiency The bus and taxi parking areas do not have designated passenger loading zones. The correction may include adding curbcuts and clear ground space; a short-term solution should be put in place in the form of marked, level zones for passengers to access these "specified public transportation vehicles."</p> <p>Solution Long term goal: add zero change-in-level spaces that meet ABA standards for loading and unloading passengers from tour buses and taxis.</p>

<p>Recommended in the interim: identify and mark clear space for a passenger loading zone that connects to an access aisle with a curb cut. Instruct vendors on using this space.</p>

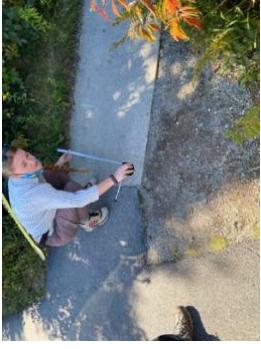
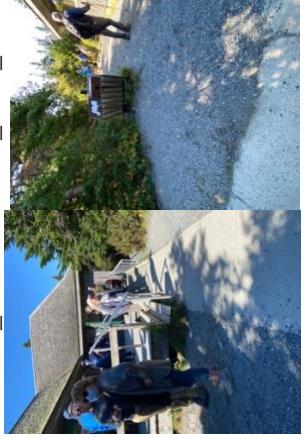
ACAD_Cadillac Mtn_LKW_035
ACAD_Cadillac Mtn_LKW_037

Location: Ground surfaces at Cadillac Summit Center Corrective Action: Replace with firm and stable surface		Criticality Serious	Timeframe Short-term	ACAD_Cadillac Mtn_LKW_033
Deficiency	Solution			
The gravel surface surrounding the giftshop/restroom building is loose and in places where it meets the ramp, asphalt, concrete path, and other surfaces, there are changes in level up to 1 inch. In addition, the trash bins do not have clear ground space.	Replace surfacing throughout with firm and stable composite and correct change in level at based of ramp. Ensure that where different surface types meet (at trail and clear space around trash, drinking fountain, kiosk, steps, and ramp) a smooth transition is maintained without changes in level.

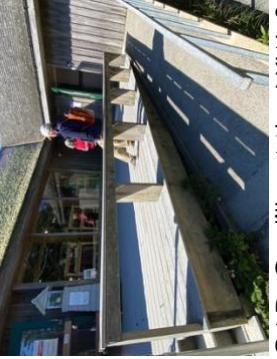
Location: Gift Shop - Deck Area Corrective Action: Add back and arm rests to bench seating	
<u>Deficiency</u> Existing railing is used as a bench seat by visitors. This railing does not meet the standards for bench seating, including height, depth, or back/arm support	<u>Solution</u> Replace the existing railing with bench seating that meets ABA standards. <u>Timeframe</u> Short-term

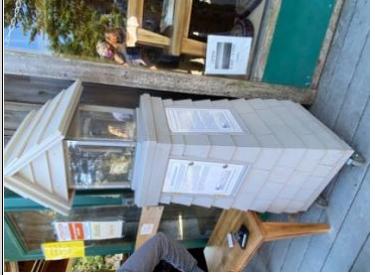
ACAD_Cadillac Mtn_LKW_041
Reference Standards and Guidelines: ABAAS 903 Benches	
Location: Gift Shop - Deck Area Corrective Action: Add accessible donation box	
<u>Deficiency</u> The opening on the donation box on the deck is 57" from the ground, making it out of reach for someone using a wheelchair or a person of short stature.	<u>Solution</u> Add an opening below 48 inches or add a lower donation box. <u>Timeframe</u> Short-term

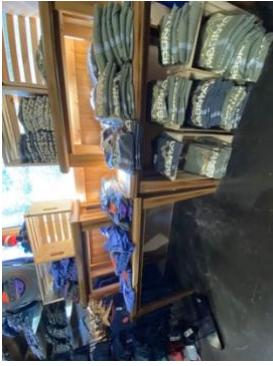
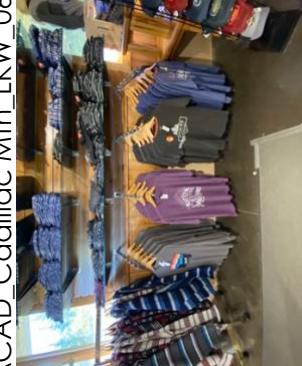
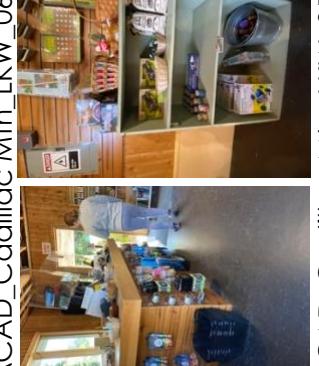
Location: Gift Shop - Interior Corrective Action: Remove protruding objects	Solution To allow people who use a white cane to navigate, permanent barriers must be placed on the floor below any protruding objects. Placing stocked crate cubbies achieves this mandate (see right side of first photo). Items that are hanging from the protruding object (second photos) are not sufficiently cane-detectable to meet the standard. The fourth photo shows an adequate solution with shelving used to negate the protruding wall hangers.	Criticality Serious Timeframe Immediate

ACAD_Cadillac Mtn_LKW_069 ACAD_Cadillac Mtn_LKW_066 ACAD_Cadillac Mtn_LKW_059 ACAD_Cadillac Mtn_LKW_068	Reference Standards and Guidelines: ABAAS 3078 Protruding Objects
Deficiency Protruding objects extending greater than 4 inches from wall between 27 and 80 inches from the floor: counter overhang (7"), table displays, hanging displays.

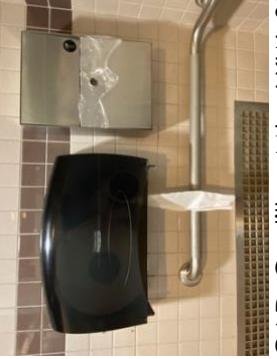
ACAD_Cadillac Mtn_LKW_050

Location: Restrooms - stalls			
Corrective Action: Reinstall grab bars and reposition dispensers			
<u>Deficiency</u> The grab bars in the accessible stalls are installed backwards and as a result they do not extend far enough on the side of the toilet. In the women's room, the toilet paper dispenser and trash receptacle are mounted too close (6') to the grab bars.	<u>Solution</u> Reinstall the grab bars so that they meet ABA standards, with the longer edge of the one-piece unit extending along the side wall at least 54" from the back wall. The shorter arm of the unit will then measure at least 24" from the centerline of the toilet bowl. The mounted fixtures should be at least 12 inches above the grab bar (with any operable parts reachable at no more than 48 inches). The trash bin should be remounted below the bar on the back wall in order to meet these requirements.	<u>Criticality</u> Serious <u>Timeframe</u> Immediate

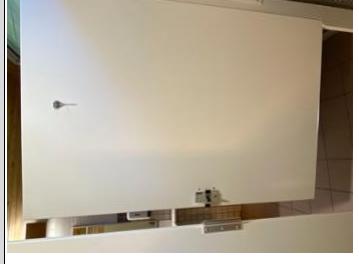
Reference Standards and Guidelines: ABAAS 308.2 Reach Ranges; 604.5 Grab Bars			
Location: Restrooms – stall doors			
Corrective Action: lower hooks and add handles			
<u>Deficiency</u> The doors to the accessible stalls have a hook on the inside that is out of reach range. Also, the doors do not have handles that permit easy opening and closing per ABA standards.	<u>Solution</u> Lower hoods to at or below 48 inches. Add D-shaped handles to the inside of the doors.	<u>Criticality</u> Serious <u>Timeframe</u> Immediate

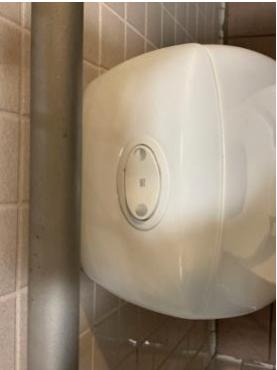
Serious	Immediate	ACAD_Cadillac Mtn_LKW_048

Location: Restrooms – toilet Corrective Action: replace flushing mechanism		<u>Solution</u>	<u>Criticality</u>	<u>Timeframe</u>	
<u>Deficiency</u> Standards related to button-operated flushing mechanisms for toilets are not specific. However, the flush controls should be both within reach range and operable with minimum dexterity. The button flush control mechanism may not meet the standard for operable parts.	<u>Replace tank/flush control or add side-mounted lever flushing mechanism that is easily operable with a closed fist. Or confirm and document that the existing system meets the standard for operable parts.</u> <u>From the ABA Technical Guide:</u> <u>Manual flush controls, including push buttons, must be usable from a point between the centerline and the open side of the fixture. A portion of the control can be outside the range if it is usable without having to reach beyond the water closer centerline from the open side.</u>

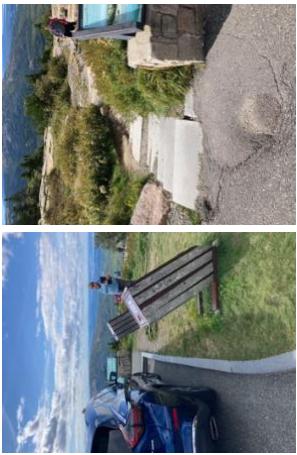
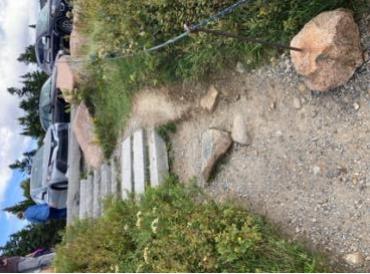
ACAD_Cadillac Mtn_KGP_129 ACAD_Cadillac Mtn_KGP_134

Location: Blue Hill Overlook			
Corrective Action: Create clear space at trash bins and wayside			
<u>Deficiency</u> The ground at the trash receptacles and the wayside does not provide enough clear ground space for access by individuals with disabilities.	<u>Solution</u> Improve the surfacing at the top of the stairs and in front of the wayside and trash bins to eliminate changes in level and slope across this area.	<u>Criticality</u> Serious	<u>Timeframe</u> Short-term
Reference Standards and Guidelines: ABAAS 1011.2 Recreational Facilities Clear Ground Space; 1015 Viewing Areas			
Location: Blue Hill Overlook			
Corrective Action: Add handrails to steps			
<u>Deficiency</u> The steps to the viewing area are hazardous and uneven and lack handrails. There are boulders in the path from steps to viewing area.	<u>Solution</u> While working toward an accessible solution for this area, an immediate need for handrails exists at this location. Adding compliant railings to both sides of the steps, a sign warning of the sloping stairs, and removal of the largest rocks at the bottom of the steps is needed to make this area safe for any but the most agile of visitors.	<u>Criticality</u> Critical	<u>Timeframe</u> Immediate

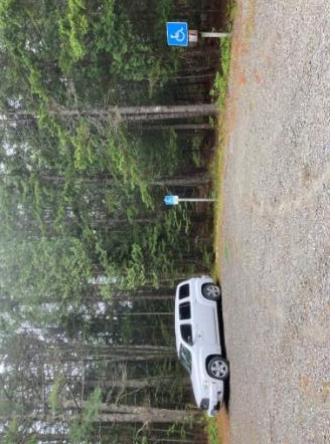
Location: Parking Lot Corrective Action: Replace parking lot ground material and stripe parking spaces	
<p><u>Deficiency</u> The parking lot where the accessible parking spaces are located does not have a firm, stable surface and it is not lined.</p> <p><u>Solution</u> Replace parking lot closest to the site with a ground material that is firm, stable, and slip resistant.</p> <p>Line the accessible parking lot with at least two van-accessible parking spaces. These spaces should be a minimum of 132" wide with an access aisle of a minimum of 60" wide or a parking space 96" wide minimum where the access aisle is 96" wide minimum.</p>	<p>Criticality Critical</p> <p>Timeframe Short-term</p>

<p>NPS_ACAD_KGP_141</p> <p>The new lined van-accessible parking spaces must be identified with the International Symbol of Accessibility and the designation "van accessible" on a sign that is a minimum of 60" above the ground to the bottom of the sign.</p> <p>NPS_ACAD_KGP_135</p>

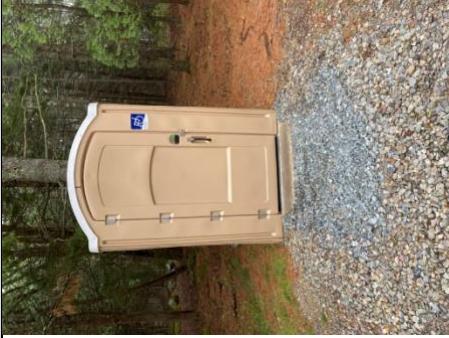
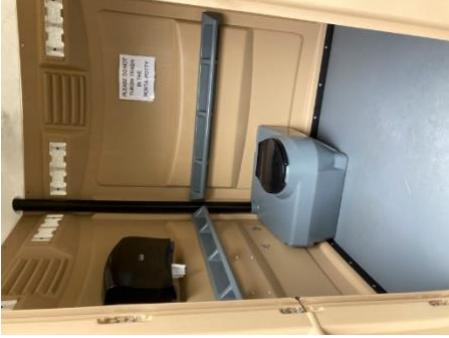
Location: Parking Lot Corrective Action: Replace porta potty and add accessible route	Deficiency The porta potty is not accessible.	Solution Replace porta-potty with one that fully complies with ABA Standards and is placed along an accessible route.	Criticality Critical	Timeframe Immediate

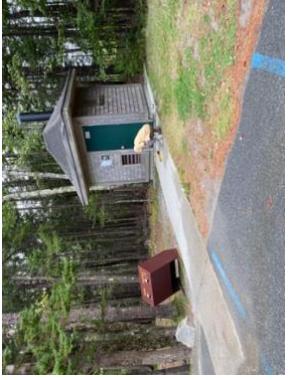
Location: Parking Lot Corrective Action: Add sign to identify accessible parking			
<u>Deficiency</u> There are no signs at the two accessible parking spaces.	<u>Solution</u> Add appropriate signage and raise the sign marking the van accessible parking space to >60". Signs identifying van parking spaces shall contain the designation "van accessible." Signs shall be 60" minimum above the finish floor or ground surface measured to the bottom of the sign.	<u>Criticality</u> Serious	<u>Timeframe</u> Immediate

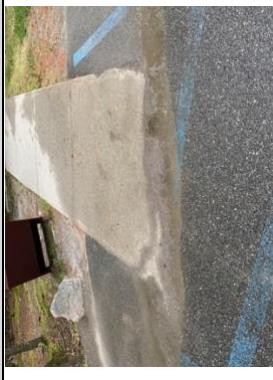
ACAD_Eagle Lake_LKW_018
Reference Standards and Guidelines: ABAAS 502.6 Parking Spaces-Identification			
Location: Parking lot at restroom Corrective Action: Regrade and restripe			
<u>Deficiency</u> ORAR extends into access aisle (slope in aisle is 4.7%). Waste receptacles are not placed along ORAR and do not have clear ground space.	<u>Solution</u> Regrade and surface the access aisle and route to/around trash cans to eliminate slope and allow loading/unloading at accessible parking spaces. Restripe parking lot to accommodate an access aisle next to, but separate from, the accessible route.	<u>Criticality</u> Serious	<u>Timeframe</u> Short-term

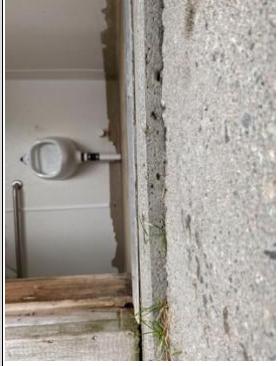
Location: Restroom Building Corrective Action: Eliminate change in level

Criticality <u>Serious</u>	Timeframe <u>Short-term</u>	ACAD_Eagle Lake_LKW_021
Reference Standards and Guidelines: ABAAS 303 Changes in Level; 304 Turning Space					
Location: Restrooms Corrective Action: Add cane detection to protruding object, lower hook

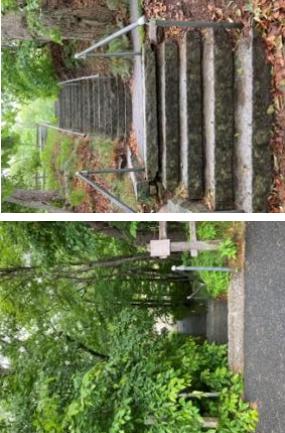
NPS_ACAD_KGP_058 NPS_ACAD_KGP_065 NPS_ACAD_KGP_064

Location: Echo Lake Beach - Stairs Corrective Action: Rebuild the stairs from the parking lot to the beach		Criticality	
Deficiency <p>The handrails on the stairs leading from the parking lot to the beach do not extend far enough at the top and bottom of each flight of stairs. The handrails have sharp ends. The steps are not of a uniform height and depth.</p>	Solution <p>Replace railings to add a 12-inch minimum horizontal top extension railing in the same direction as stair flight and a sloped bottom extension railing one tread depth minimum beyond the last riser, nosing in the same direction as stair flight. Rebuild the steps with uniform heights between 4-7 inches and uniform depths of 11-inches.</p>	Critical Critical Timeframe Short-term

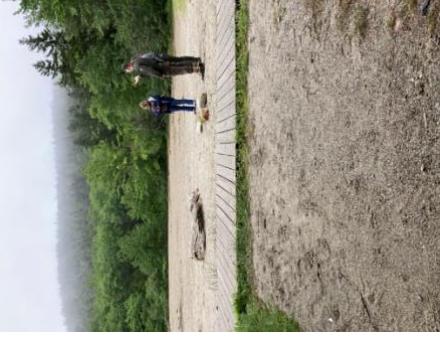
Location: Echo Lake Beach - Path from stairs to boardwalk Corrective Action: Replace path to decrease gaps in materials

NPS_ACAD_KGP_067	NPS_ACAD_KGP_066
<u>Deficiency</u>	<u>Solution</u>	Criticality	Timeframe		
The transitions from pavement to sand and sand to boardwalk at the bottom of the steps are too large (>1inch, >3inches).	Extend the boardwalk laterally to the bottom of the steps or replace the sand with ground material extending from the pavement to the boardwalk that is stable, firm, and slip resistant and ensures no gaps between materials.	Serious	Immediate

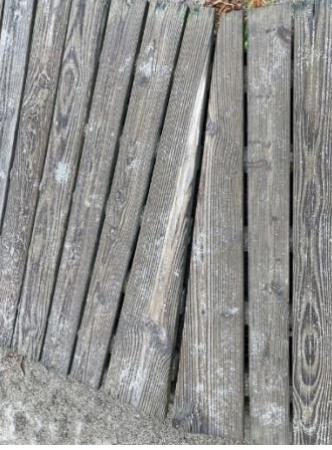
Location: Echo Lake Beach - Boardwalk Corrective Action: Reconstruct curve in the boardwalk				
<u>Deficiency</u> The gaps between the boards at the curve of the boardwalk are too large (5/8-inch to 1.5-inches).	<u>Solution</u> Reconstruct the curve of the boardwalk to decrease the gap between the boards to less than ½ inch.	<u>Criticality</u> Critical	<u>Timeframe</u> Immediate	NPS_ACAD_KGP_070

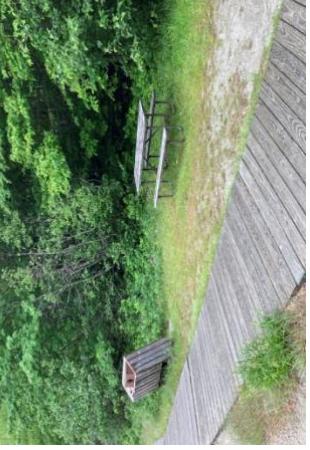
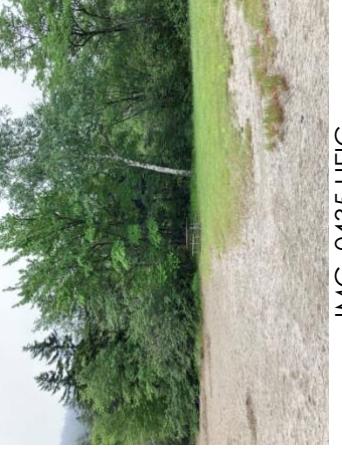
Location: Echo Lake Beach - Picnic Area Corrective Action: Replace picnic tables with wheelchair accessible picnic tables and extend boardwalk		Criticality	Image
Deficiency	Solution	Timeframe	
The two picnic tables at the beach do not have accessible seating or clear ground space around them.	<p>Remove both picnic tables or replace both picnic tables with wheelchair accessible picnic tables with appropriate clear space. Accessible picnic tables include a minimum of one wheelchair seating space, including knee and toe clearance beneath the table. In addition, a minimum 36 inches of clear ground space shall be provided on all sides of the accessible picnic tables, measured from the back edge of the benches.</p> <p>Recommend extending the boardwalk to and underneath both picnic tables.</p>	Short-term

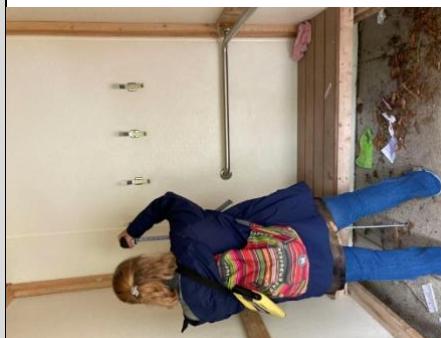
NPS_ACAD_KGP_081

Location: Echo Lake Beach - Changing Rooms Corrective Action: Lower coat hooks and perform maintenance on lock mechanisms		<u>Criticality</u> Serious	<u>Timeframe</u> Immediate
<u>Deficiency</u>	<u>Solution</u>		
The hooks inside the accessible changing rooms are too high (59 inches). The lock mechanism is difficult to operate.	Lower hooks to <48 inches to be within reach range (not on wall behind bench) for individuals using wheelchairs or who have a short stature. Perform maintenance on the lock mechanism to improve the ability for individuals with impaired hand function to be able to operate the lock mechanism.

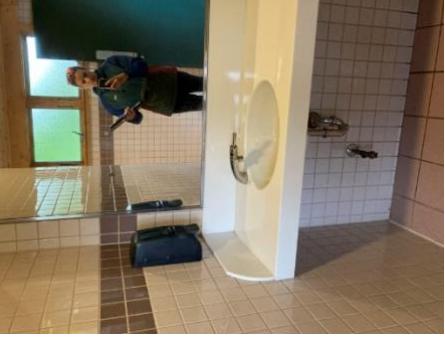
Reference Standards and Guidelines: ABA 606.5	
Location: Echo Lake Beach – Men’s and Women’s Restrooms	
Corrective Action: Increase the accessibility of features within the accessible rest room stalls	
<u>Deficiency</u> The flush control is on the closed side of the toilet, out of reach range.	<u>Solution</u> Replace the toilet with one that has the flush control on the open side of the toilet to be within reach range of individuals so they are able to flush.
	<u>Criticality</u> Serious
	<u>Timeframe</u> Short-term

<u>Deficiency</u> The sanitary basket is behind the toilet, out of reach range.	Move the sanitary basket to the open side of the toilet so that individuals do not have to reach across the toilet bowl to access the sanitary basket.
The grab bars are not oriented correctly. (CONTINUED)

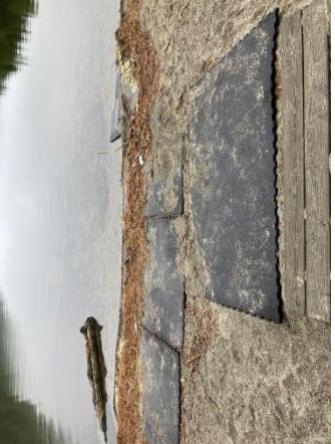
NPS_ACAD_KGP_071

Location: Echo Lake Beach - Boardwalk Corrective Action: Replace rubber mats with Mobi-Mat	
<u>Deficiency</u> The transition from the boardwalk to the rubber mat has a 4-inch gap. There are large gaps between each square of the rubber mat.	<u>Solution</u> Replace rubber mats with a Mobi-Mat that attaches to the boardwalk (with a gap $<\frac{1}{2}$ inch) that is removable to allow for ground maintenance that extends into the water.
	<u>Criticality</u> Critical
	<u>Timeframe</u> Immediate

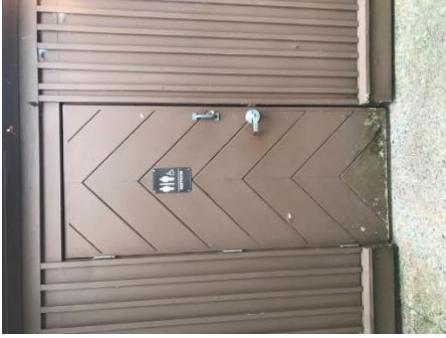
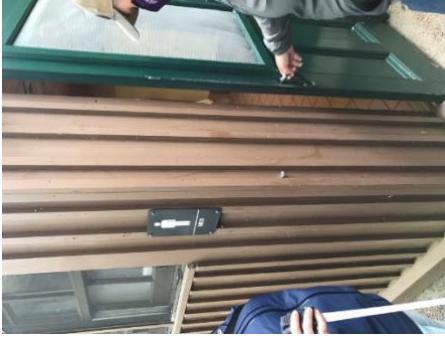
ACAD_Fabbri_LMK_084
<u>Deficiency</u> Restroom signs are placed incorrectly.	<u>Solution</u> Where a tactile sign is provided at a door, the sign shall be located alongside the door at the latch side.	<u>Criticality</u> Critical	<u>Timeframe</u> Immediate

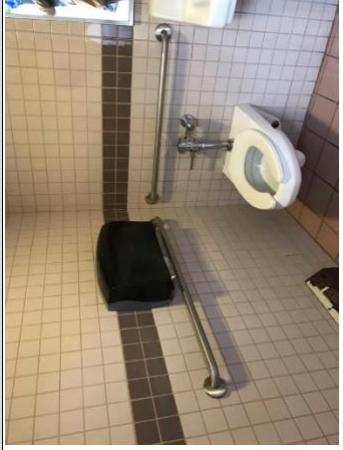
ACAD_Fabbri_LMK_081
			ACAD_Fabbri_LMK_079

Location: Family Restroom Corrective Action: Lower baby changing station		<u>Solution</u> Lower the baby changing station so that the height of the opening mechanism is <48" to be within reach range.	
<u>Deficiency</u>	The baby changing station is too high outside of reach range.	<u>Criticality</u>	Serious
Reference Standards and Guidelines: ABBAS 308.2.1			
Location: Family Restroom Corrective Action: Replace toilet		<u>Solution</u> Replace the toilet with one that has the flush control on the open side of the toilet to be within reach range, so individuals may be able to flush. Toilet seat height should be 17-19" to comply with accessibility standards.	
<u>Deficiency</u>	The flusher is on the wrong side of the toilet.	<u>Criticality</u>	Serious
Reference Standards and Guidelines: ABBAS 604.6, 604.4

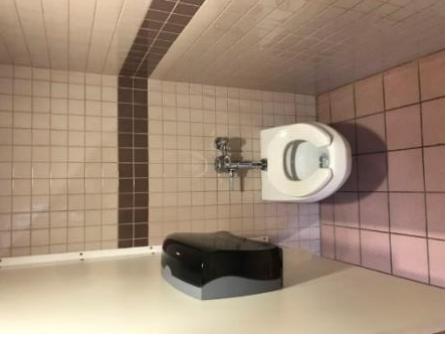
Location: Men's Restroom Corrective Action: Increase the accessibility of features within the accessible rest room stalls				
Deficiency	Solution	Criticality	Timeframe	
Width of accessible stall does not meet standards.	<p>Recommend redesigning stall to meet accessibility standards. Stall dimensions should be 60" minimum measured perpendicular from the side wall and 56" minimum measured perpendicular from the rear wall. Recommend moving stall wall further out so that urinal is located within accessible stall.</p> <p>Urinal is currently too high.</p> <p>Grab bars are not installed.</p>	<p>Serious</p>	<p>Short-term</p>

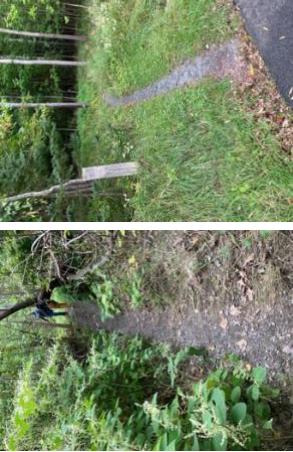
ACAD_Grt Meadow Loop_KGO_292 ACAD_Grt Meadow Loop_KGO_311

Location: Great Meadow Loop Corrective Action: Widen trail and provide passing spaces		<u>Criticality</u> Serious	<u>Timeframe</u> Short-term
<u>Deficiency</u> Tread width of trail is as narrow as 10" in various areas.	<u>Solution</u> Recommend widening trail so clear tread width meets minimum standard of 36". Where the tread width is less than 60", passing spaces must be provided at intervals of at least 1000 feet.

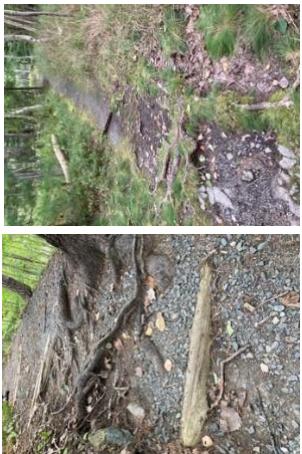
ACAD_Grt Meadow Loop_KGO_289 ACAD_Grt Meadow Loop_KGO_323

Deficiency	Solution	Criticality	Timeframe	Image	Notes
Location: Great Meadow Loop Corrective Action: Reduce tread obstacles There are various tread obstacles such as tree roots throughout the trail that are higher than the 2" maximum allowed.	The limit on the height of tread obstacles on trails, passing spaces, and resting intervals is based on the surface material used. When the trail surface is constructed of materials other than concrete, asphalt, or boards, tread obstacles are permitted to be a maximum of 2 inches high. Use fill materials to level out the surface and reduce tread obstacle height to 2" or less.	serious	Interim

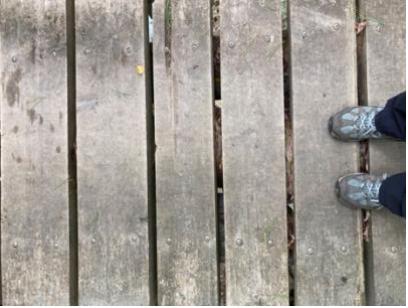
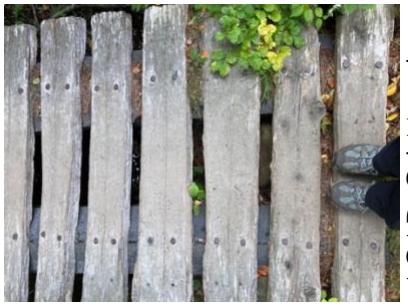
<u>Deficiency</u> Two bridges on the trail have openings ranging from 1-3"	Fill gaps or rebuild bridges so that gaps are a maximum of $\frac{1}{2}$ ".	Serious	Fill gaps or rebuild bridges so that gaps are a maximum of $\frac{1}{2}$ ".	Interim

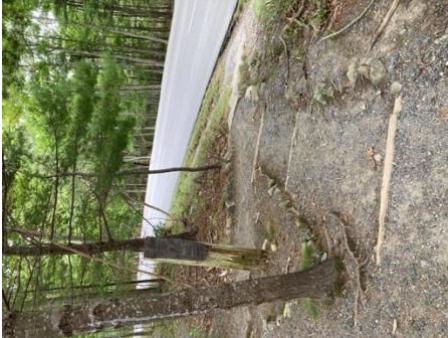
Criticality Serious	Timeframe Interim
Deficiency	Solution			
Numerous sections of the trail exceed the allowable running slope for accessible trail segments.	Regrade sections of trail to ensure the running slopes adhere to ABA standards. Trail segments of any length may be constructed with running slopes up to 5%. To accommodate steep terrain, trails may be designed with shorter segments that have a running slope and length, as shown in the table below, with resting intervals at the top and bottom of each segment.

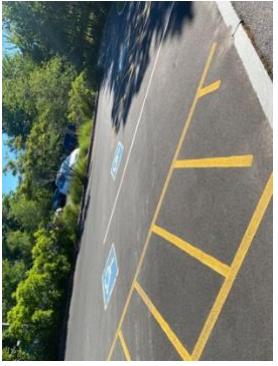
Location: Main Visitor Parking Lot Corrective Action: Rescope and restripe the accessible parking and access aisles			
<u>Deficiency</u> Accessible parking spaces are not properly marked for angled parking. Some van accessible spaces do not have an access aisle on the passenger side, which is required for angled spaces.	<u>Solution</u> As part of the upcoming restriping project, rescope the parking lot to determine required minimum number of accessible spaces. Then, either stripe the lot and mark accessible spaces vertically (which can have shared access aisles) or maintain angled parking and add access aisles as required. Additionally, ensure that each aisle is met by a curb cut at the sidewalk.	<u>Criticality</u> Serious	<u>Timeframe</u> Immediate

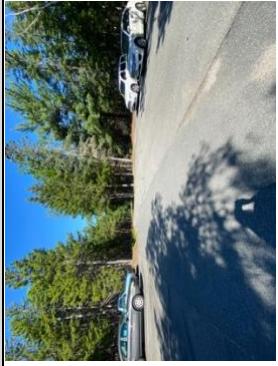
NPS_ACAD_LKW_306
Reference Standards and Guidelines: ABAAS 502.3 and 502.4

<u>Deficiency</u> The slope in the employee lot exceeds the maximum of 2% around the accessible space. In addition, there is not a marked access aisle for the space.	<u>Solution</u> Rergrade and level the employee lot to meet the standard. Add an access aisle to the accessible parking space.	<u>Criticality</u> Serious	<u>Timeframe</u> Short-term

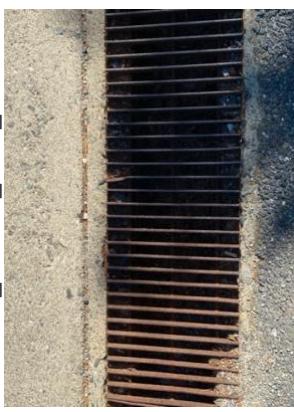
NPS_ACAD_LKW_302
				Reference Standards and Guidelines: ABAAS 302 and 303

Location: Route from parking to visitor center - surfaces Corrective Action: Repair paving, replace grates		<u>Criticality</u> Serious	<u>Timeframe</u> Short-term	NPS_ACAD_LKW_342 NPS_ACAD_LKW_300
Deficiency	Solution			
The route from the main visitor parking lot to the visitor center building consists of 52 stone steps with spacious landings. The surfaces on landings and associated routes have spalling and cracks resulting in changes in level. Some grates have openings that exceed the maximum allowed in the direction of travel.	Replace grates with ones that have cross bars to lessen the open spaces where a wheelchair caster could be caught. Perform maintenance on the paved surfaces to eliminate changes in level.

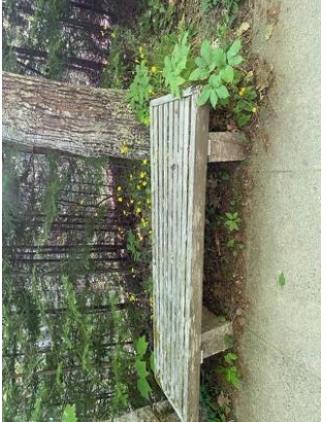
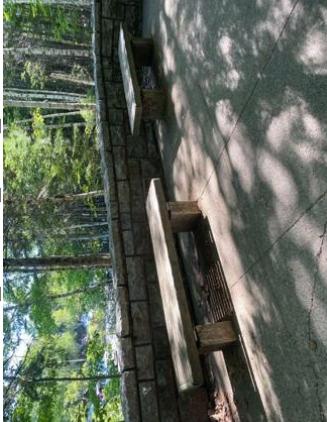
Criticality Serious Timeframe Immediate
Deficiency	Solution			
The benches placed at landings along the route do not have back or arm rests.	Add accessible bench seating with back and armrests. Include areas for companion seating for those needing an adapted chair. Benches should meet standards for height and placement.			
Reference Standards and Guidelines: ABAAS 903 and 10112.1				NPS_ACAD_LKW_297

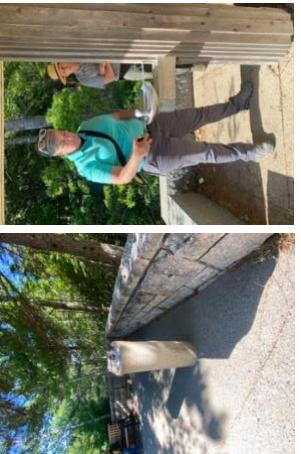
NPS_ACAD_LKW_307 NPS_ACAD_LKW_287
Reference Standards and Guidelines: ABAAS 602 and 307

Location: Route from parking to visitor center – water fountain			
Corrective Action: add dual level accessible fountain			
<u>Deficiency</u> Drinking fountains do not provide knee and toe clearance or meet height standards for use in a seated position. The fountain at the parking lot pavilion is a protruding object.	<u>Solution</u> Replace existing outdoor drinking fountains with fountains that allow for clear ground space and clearance as well as spout height. Provide two spouts at different heights to accommodate the widest range of users. *Because the pillar-mounted fountain protrudes into the accessible route and is not cane detectable, it poses a hazard for visitors who are blind or have low vision. Add a detectable barrier beneath the fountain to bring it to standard.	<u>Criticality</u> Serious <u>Timeframe</u> Short-term

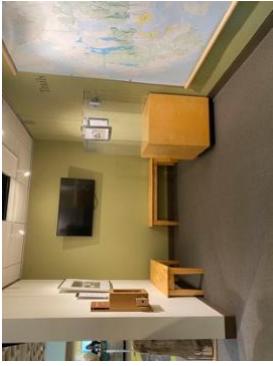
Location: Visitor Center Corrective Action: Add accessible seating	<u>Deficiency</u> Seating does not meet standards for back and arm rests, making it difficult for some users to sit or stand from the benches. <u>Solution</u> Add or replace with seating that has back and arm rests and meets standard for height. Back rests may not be necessary when the bench is affixed to the wall, but arm rests or grab bars are still necessary.	<u>Criticality</u> Serious	<u>Timeframe</u> Immediate

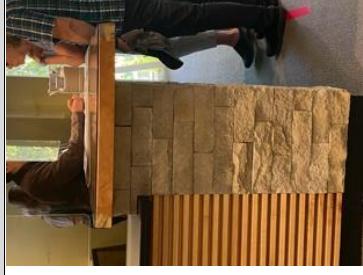
NPS_ACAD_LKW_337

NPS_ACAD_LKW_323
Location: Visitor Center Corrective Action: Add cane detection to counters and wall mounted objects	<u>Deficiency</u> The countertop at the information desk in the visitor center protrudes into the accessible route and is not detectable by someone using a white cane. The "ask an artist" box also exceeds the limits for protrusion from the wall. <u>Solution</u> Both the countertop and the mounted box can be brought to standard by adding either a lip to hang below 27 inches from the ground or placing a fixture on the floor below. Evaluate the wall mounted drinking fountain for compliance with standard as well.	<u>Criticality</u> Serious	<u>Timeframe</u> Short-term

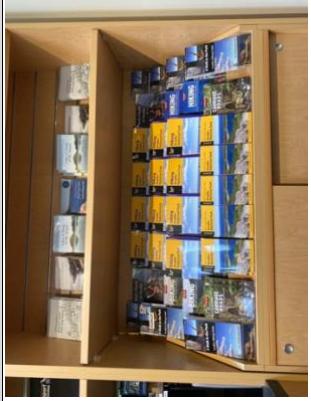
Location: Gift Shop Corrective Action: Train staff; arrange stock	<u>Deficiency</u> Some items in the gift shop are beyond the reach range of someone using a wheelchair. <u>Solution</u> Work with the gift shop concessionaire to stock inventory vertically whenever possible. When similar items are stocked on shelves vertically rather than horizontally, they are reachable by visitors using a wheelchair and others with a shorter reach range.	<u>Criticality</u> Serious <u>Timeframe</u> Immediate

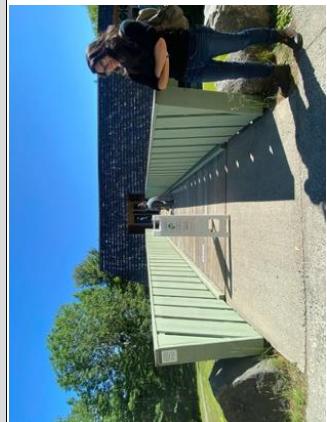
Reference Standards and Guidelines: ABAAS 402 NPS_ACAD_LKW_339

Reference Standards and Guidelines: ABAAS 308; Section 504 of the Rehabilitation Act of 1973, as amended NPS_ACAD_LKW_341
Location: Bridge to VC – gift shop entrance Corrective Action: Remove sign; train staff	<u>Deficiency</u> Signs are placed in the accessible route and do not leave adequate clear width of 36 inches on either side. <u>Solution</u> Remove the temporary signs and train staff on proper clear width needed for accessible routes.	<u>Criticality</u> Critical <u>Timeframe</u> Immediate

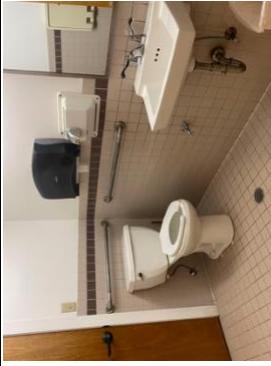
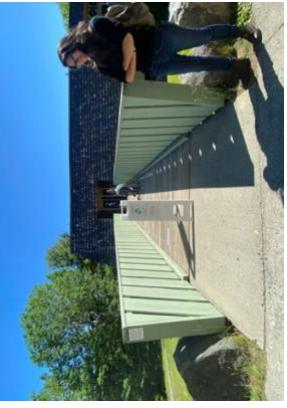
Reference Standards and Guidelines: ABAAS 605			NPS_ACAD_LKW_340

Location: Restroom on lower floor			
Corrective Action: Reposition toilet			
Deficiency The grab bar behind the toilet is too short and does not extend far enough past the tank to be used for a side transfer onto the toilet.	Solution Reposition the toilet to allow for enough space for back and side grab bars. (Ensure that the flush handle is on the side away from the wall.)	<u>Criticality</u> Serious	<u>Timeframe</u> Short-term
Reference Standards and Guidelines: ABAAS 604			NPS_ACAD_LKW_318
Location: Visitor Center Entrance Ramps			
Corrective Action: Reroute (immediate) and add landings (short-term)			
Deficiency The slope on the first ramp/ bridge to the visitor center (the gift shop entrance) is much higher (>11%) than the slope on the second bridge.	Solution Place a sign directing those who prefer a less steep ramp to the visitor center to use the second bridge. *A longer-term solution is to add level landings at the top and bottom of the ramp to provide a resting space.	<u>Criticality</u> Serious	<u>Timeframe</u> Immediate

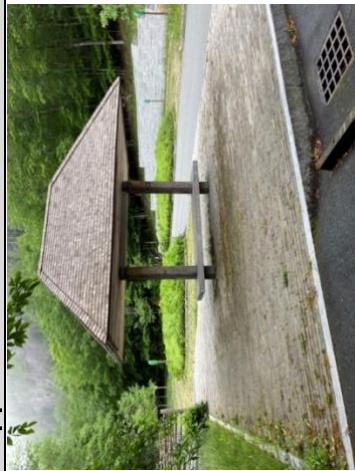
NPS_ACAD_KGP_099

Location: Village Green, Echo Lake, Hulls Cove VC, Sand Beach, Jordan Pond and other Shuttle Stops			
Corrective Action: Replace benches without back support with benches that have back support			
<u>Deficiency</u>	<u>Solution</u>	<u>Criticality</u>	<u>Timeframe</u>
The benches at the shuttle stops that were evaluated during this site visit do not have backrests.	Replace the current benches with benches that have back support (at least 42 inches long and extend from a point of two inches maximum above the seat surface to a point of 18 inches minimum above the seat surface. The back support should be 2.5 inches maximum from the rear edge of the seat measured horizontally. The benches should be 42 inches long minimum, 20-24 inches deep, and 17-19 inches above the sidewalk.	Serious	Short-Term

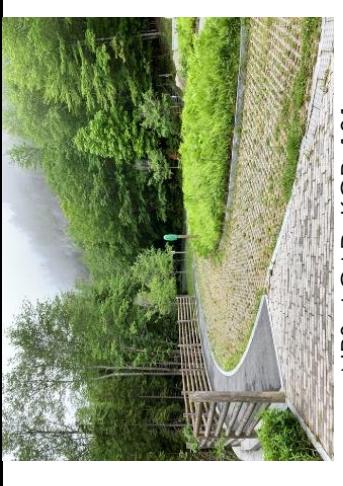
Reference Standards and Guidelines: ADA/ABA 307 Protruding objects	
Location: Echo Lake Shuttle Stop	
Corrective Action: Find and label an accessible loading zone	
<u>Deficiency</u> There is an asphalt loading zone that is 60 inches in depth, but curved so the bus is not able to pull in flush to the sidewalk.	<u>Solution</u> One accessible loading zone is required every 100 ft at a specifically designed passenger loading zone. Find a location 96 inches long x 60 inches deep that has a slope of no greater than 1:48. Mark as the accessible loading zone.

<u>Criticality</u> Serious <u>Timeframe</u> Short-Term

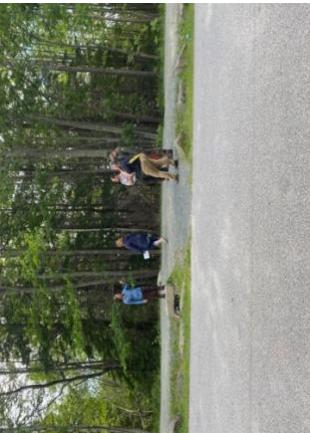
NPS_ACAD_LKW_049

Location: Ocean Path at Old Soaker Parking lot			
Corrective Action: Add signs to indicate accessibility of Ocean Path and route from accessible parking			
Deficiency	Solution	Criticality	Timeframe
There is no information on where and how to find accessible parking, routes, amenities, and trails.	<p>Add simple signs with the international accessibility symbol (ISO) to identify routes to accessible features.</p> <p>Add directional signs, using accessible fonts and contrast with the ISO symbol for indicating the distance to points of interest, e.g. Sand Beach.</p> <p>Clearly identify road crossing from parking lot to trail with "no parking" signs and striping.</p>	Serious	Immediate

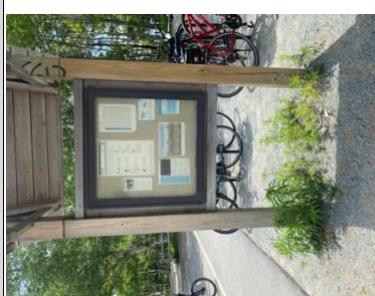
NPS_ACAD_LKW_063	
Reference Standards and Guidelines: ABAAS 307

NPS_ACAD_LKW_059	
Reference Standards and Guidelines: ABAAS 604, 606, and 609			
Location: Bus Stop Corrective Action: Add cane detection to bulletin board			
Deficiency	Solution	Criticality	Timeframe
Informational panels / bulletin board at bus stop is not cane detectable: bottom of frame is 32.5 inches from ground.	Add a lip to the bottom of the panel to bring it to within 27 inches from the ground or add barrier at ground level to make the space cane detectable.	Serious	Immediate

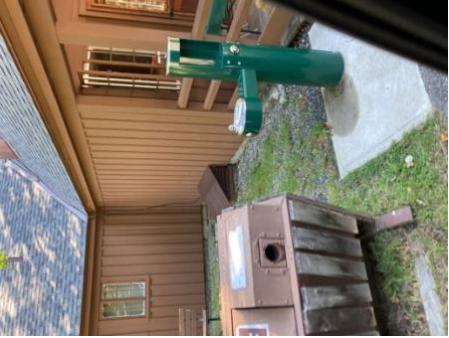
ACAD_KGP_002

Location: Ranger's Station Corrective Action: Increase clear space around water fountain	<u>Deficiency</u> The concrete pad in front of the water fountain is too small (56"x39"). As a result, individuals who use the fountain are in the path of vehicle traffic which is a major safety concern.	<u>Solution</u> Increase clear space around water fountain by increasing the size of the concrete pad away from the path of vehicle traffic.	<u>Criticality</u> Critical	<u>Timeframe</u> Short-term

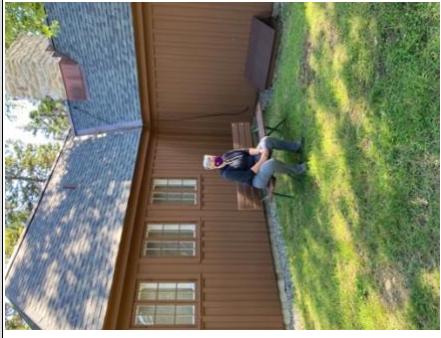
ACAD_KGP_015
Reference Standards and Guidelines: ABA 305	Location: Ranger's Station Corrective Action: Relocate bench	<u>Deficiency</u> The bench is not along an accessible route.	<u>Solution</u> Relocate the bench along an accessible route to improve access for all individuals.	<u>Criticality</u> Minor	<u>Timeframe</u> Immediate	Reference Standards and Guidelines: ABAAS 402; 1011.12

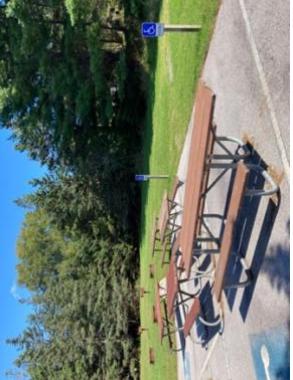
ACAD_KGP_074

ACAD_KGP_064
Reference Standards and Guidelines: ABA 403					
Location: Group Campsites Corrective Action: Add 1 accessible picnic table to the current accessible group site and at least two accessible fire rings.	<u>Deficiency</u> There is only one accessible picnic table and no accessible fire rings in the accessible group campsite.	<u>Solution</u> Ensure at least 20%, but no less than 2, picnic tables, fire rings, and pedestal grills are accessible at each of the accessible group sites.	<u>Criticality</u> Serious	<u>Timeframe</u> Short-term

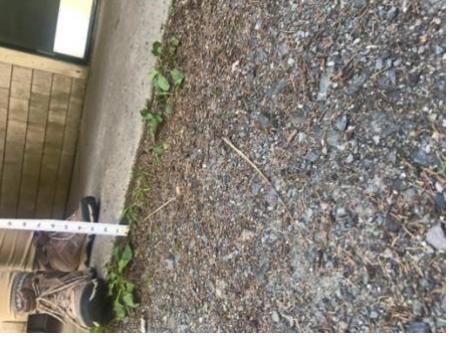
Location: Restroom Building Corrective Action: Repair change in level			
<u>Deficiency</u> There is a 1" change in level at the threshold of the restroom building.	<u>Solution</u> Build up the surface material to ensure a maximum change in level of 1/4 inch.	<u>Criticality</u> Serious	<u>Timeframe</u> Immediate

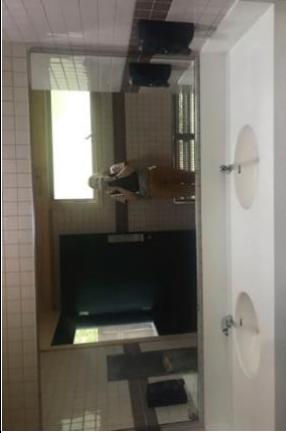
ACAD_S seawall Picnic_LMK_002			
Reference Standards and Guidelines: ABBAS 303.2			
Location: Women's, Men's, Family Restrooms Corrective Action: Wrap pipes under sink			
<u>Deficiency</u> The pipes underneath the sink are exposed.	<u>Solution</u> Wrap the pipes under the sinks in the restrooms to prevent injury from hot/cold and sharp edges for someone who uses a wheelchair and positions their legs under the sink while washing their hands.	<u>Criticality</u> Critical	<u>Timeframe</u> Immediate

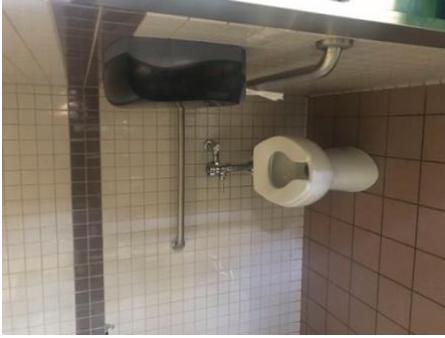
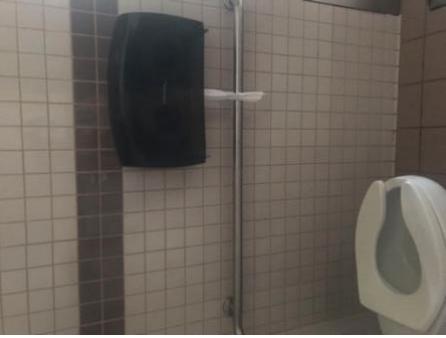
Location: Women's, Men's, Family Restroom Corrective Action: Re-install grab bars and toilet paper dispenser	
<p><u>Deficiency</u> Grab bars do not meet ABA standards.</p> <p><u>Solution</u> The side wall grab bar shall be 42" long minimum, located 12" maximum from the rear wall and extending 54" minimum from the rear wall. The rear wall grab bar shall be 36" long minimum and extend from the centerline of the water closet 12" minimum on one side and 24" minimum on the other side. The space between the wall and the grab bar shall be 1.5".</p> <p>Toilet paper dispenser is located too close to grab bars.</p>	<p><u>Criticality</u> Serious</p> <p><u>Timeframe</u> Short-term</p> <p>Toilet paper dispenser must be 7" minimum and 9" maximum in front of the center of the toilet. The outlet of the dispenser shall be 15" minimum and 48" maximum above the floor and shall not be located behind grab bars. If toilet paper dispensers are installed above the side wall grab bar, the outlet of the toilet paper dispenser must be 48" maximum above the finish floor and the top of the gripping surface of the grab bar must be 33 inches" minimum and 36" maximum above the floor.</p>

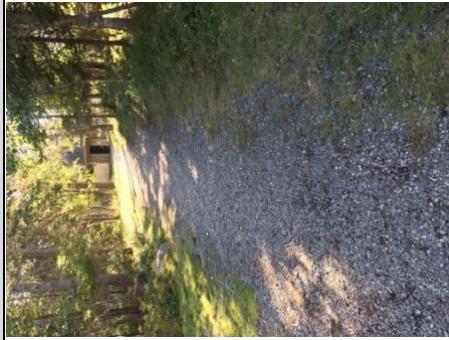
ACAD_Sewwall Picnic_LMK_024

Location: Family Restroom Corrective Action: Lower baby changing station and hook	
<u>Deficiency</u> Path to restroom building is too narrow and has slope grades up to 9%.	<u>Solution</u> Trim overgrown vegetation to ensure packed gravel paths are a minimum of 36" wide (paths may be reduced to 32" for a length of 24", but these reductions must be separated by segments that are a minimum of 48" long and 36" wide). Regrade path so path has a grade of <5%.

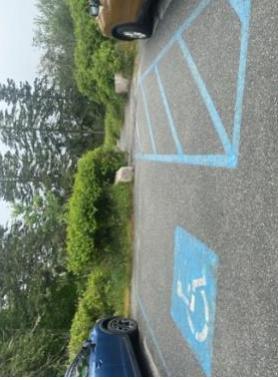
<p>Location: Parking lot</p> <p>Corrective Action: Install accessible parking sign</p> <p><u>Deficiency</u> There is no sign identifying the accessible parking space at the trail entrance. The sign at the space near the toilet says, "Handicapped Parking."</p>	<p><u>Solution</u> Install a sign indicating the accessibility of the space (van-accessible, if wide enough) and containing the International Symbol of Accessibility (ISA). Ensure that the sign is 60 inches minimum from the ground to the bottom edge. Replace the sign at the accessible space near the toilet with one that uses the more up-to-date term "accessible" rather than "handicapped," which is not favored.</p>	<p><u>Criticality</u> Serious</p> <p><u>Timeframe</u> Immediate</p>

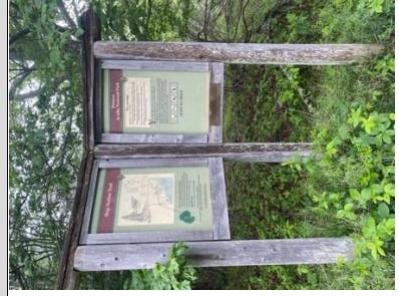
NPS_ACAD_LKW_176

NPS_ACAD_LKW_214
<p>Reference Standards and Guidelines: ABAAAS 502.6</p> <p>Location: Trailhead at parking lot</p> <p>Corrective Action: Install kiosk with trail information</p> <p><u>Deficiency</u> Visitors do not have access to the information needed to determine their use of the trail.</p>	<p><u>Solution</u> Move the existing two-panel kiosk close to the parking lot and add trail segment information including slope, surfacing and distance.</p>	<p><u>Criticality</u> Serious</p> <p><u>Timeframe</u> Short-term</p>

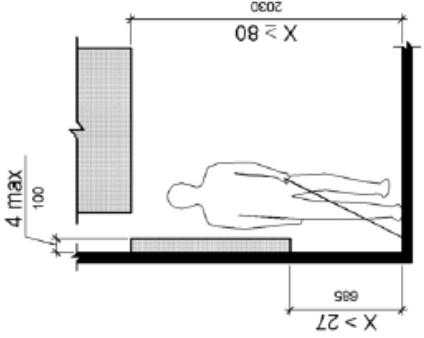
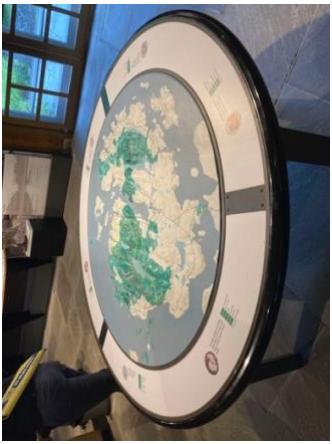
Location: Nature Center Corrective Action: Install cane detection at exhibits	<p><u>Solution</u></p> <p>Install a lip that brings the outside edge of shelves, tables, and other features that are deeper than four inches down to the standard height for cane detectability (27 inches from floor); or install a barrier on the ground below.</p>

<p><u>Criticality</u> Critical</p> <p><u>Timeframe</u> Immediate</p> <p>NPS_ACAD_KGP_246</p>

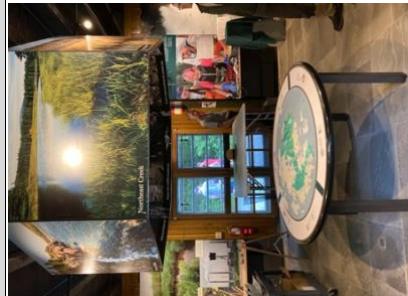
Location: Nature Center Corrective Action: Raise hanging panels	Deficiency Panels hung from the ceiling over the map table extend below the 80-inch standard for protruding objects (see illustration above).	Solution Raise the panels so that the bottom edge is higher than 80 inches from the ground.	<u>Criticality</u> Critical	<u>Timeframe</u> Immediate

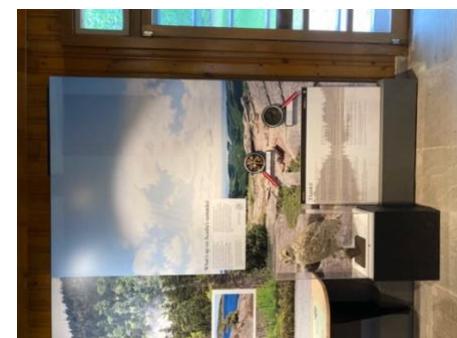
NPS_ACAD_KGP_249
Reference Standards and Guidelines: ABAAS 307.2						
Location: Nature Center Corrective Action: Remove sharp edges	Deficiency Clear plexiglass displays with sharp edges are particularly hazardous for people with low vision.	Solution Bevel and smooth edges of the plexiglass box holding the taxidermied owl (and others as necessary). Marking the edges with colored tape can also improve their visibility and prevent injury.	<u>Criticality</u> Serious	<u>Timeframe</u> Short-term

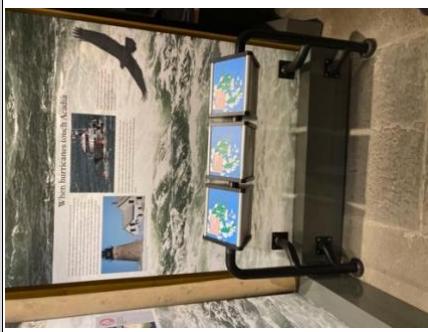
NPS_ACAD_KGP_267

Location: Nature Center Corrective Action: Reduce pressure necessary to operate moveable components		<u>Criticality</u> Serious	<u>Timeframe</u> Immediate
<u>Deficiency</u>	<u>Solution</u>		
The hurricanes exhibit has an operable component that requires excessive pressure to manipulate. It was measured at 9 psi. (This display is also not cane detectable – see above.)	Reduce the pressure necessary to move the display components to less than or equal to five pounds.

Reference Standards and Guidelines: ABAAS 309.4

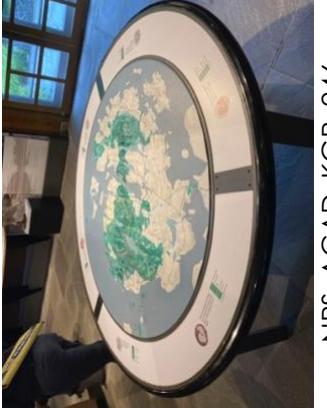
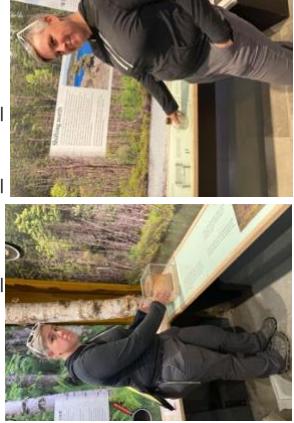
NPS_ACAD_KGP_280 NPS_ACAD_KGP_279

Location: Nature Center Corrective Action: Provide meaningful and accessible tactile exhibits	Deficiency The topographic map is too wide to be reached by someone using a wheelchair and the key is only provided visually. In addition, tactile objects in the wall panel displays do not offer a full or equivalent experience related to the objects behind the plexiglass barrier. Solution Provide replicas or duplicates of key meaningful artifacts for tactile displays. Choose items that are unique or outside the range of typical visitor experience, for example the woven basket as opposed to maple syrup jug. Consider adding additional tactile features to existing exhibits, for example tree bark samples.	Criticality Critical Timeframe Immediate NPS_ACAD_KGP_246

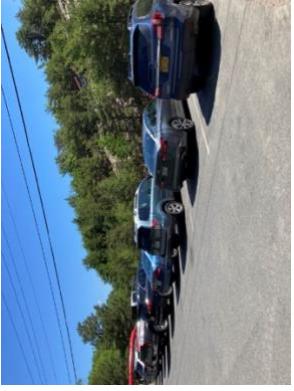
NPS_ACAD_KGP_368

Location: The Parking Lot Corrective Action: Line and mark a van-accessible parking space			
<u>Deficiency</u> There are no accessible parking spaces in The Tarn area parking lot.	<u>Solution</u> Re-line the parking lot to include a van-accessible parking space that is a minimum of 132 inches wide with a 60-inch access aisle on the passenger side of the space that adjoins an accessible route. The van accessible parking space can be 96 inches wide if the access aisle is 96 inches.	<u>Criticality</u> Serious	<u>Timeframe</u> Short-Term
Reference Standards and Guidelines: ABAAS 502			
Location: The Tarn Parking Lot Corrective Action: Change the ground material between the parking lot pavement and kiosk			
<u>Deficiency</u> There is loose, medium-sized gravel in front of the trailhead kiosk.	<u>Solution</u> Change the loose gravel in front of kiosk to a material that is firm, stable, and slip resistant.	<u>Criticality</u> Serious	<u>Timeframe</u> Short-Term

Reference Standards and Guidelines: ABAAS 302.1

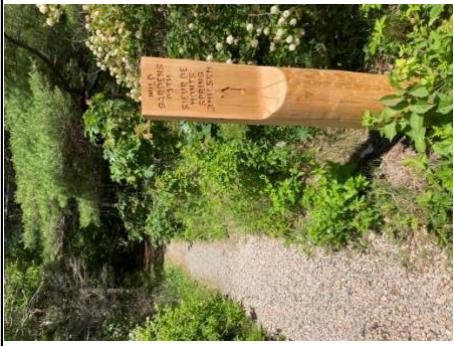
NPS_ACAD_KGP_376

Location: Directional Trail Signs Corrective Action: Increase lettering contrast		<u>Criticality</u> Serious	<u>Timeframe</u> Short-Term
<u>Deficiency</u> There is not enough contrast between trail name lettering and the wooden post.	<u>Solution</u> Recommend making the directional signs more easily readable by individuals who have low vision by increasing the color contrast between the lettering and the wooden post.

Reference Standards and Guidelines: ABAAS 703.5; Rehabilitation Act of 1973, as amended, Section 504

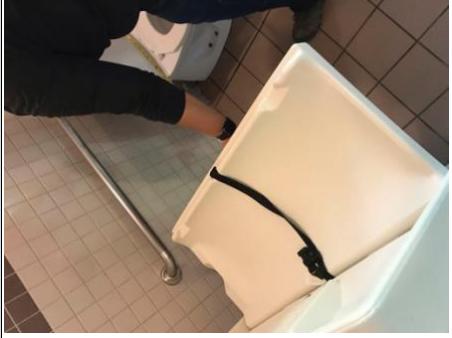
ACAD_Thompson_Picnic_IMK_022

Location: Family Restroom Corrective Action: Reduce the amount of force needed on door			
<u>Deficiency</u>	<u>Solution</u>	<u>Criticality</u>	
The entry door requires excessive force to open.	Reduce the amount of force needed to open the door to 5 pounds maximum.	Critical	No photo
Reference Standards and Guidelines: ABBAS 604.5, 604.7, 609.3, 609.4			
Location: Family Restroom Corrective Action: Reposition changing table			
<u>Deficiency</u>	<u>Solution</u>	<u>Criticality</u>	
The placement of the changing table does not allow for maneuvering into position.	Reposition the changing table so that it folds down from the rear wall.	Serious	
Reference Standards and Guidelines: ABBAS 604.8.1.1.

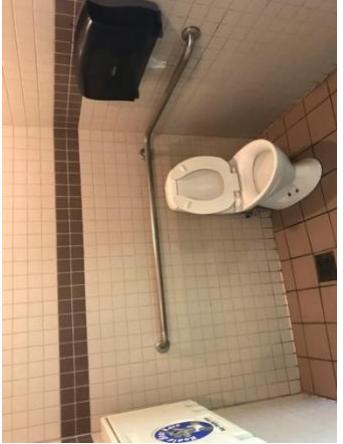
Location: Family Restroom Corrective Action: Re-install grab bars	<u>Deficiency</u> Grab bars are incorrectly installed, and the side wall is too short for correct installation at 52.75".	<u>Solution</u> The side wall should be built out so it measures 54" in length. Reinstall new grab bars where the side wall grab bar is 42" long minimum, located 12" maximum from the rear wall and extending 54" minimum from the rear wall and the rear wall grab bar is 36" long minimum and extend from the centerline of the water closet 12" minimum on one side and 24" minimum on the other side.	<u>Criticality</u> Serious	<u>Timeframe</u> Short-term

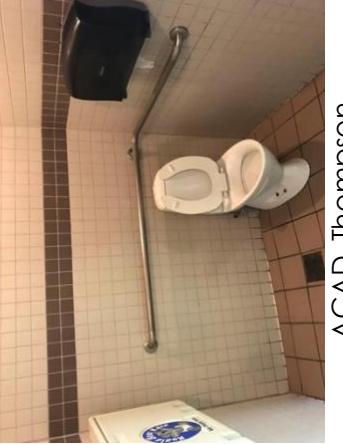
ACAD_Thompson_Picnic_LMK_020
Location: Family Restrooms Corrective Action: Relocate toilet paper dispenser	<u>Deficiency</u> The space between the toilet paper dispenser and grab bars is not sufficient.	<u>Solution</u> Reinstall the toilet paper dispenser 7" minimum and 9" maximum in front of the toilet measured to the centerline of the dispenser. The outlet of the dispenser shall be 15" minimum and 48" maximum above the finish floor and shall not be located behind grab bars.	<u>Criticality</u> Serious	<u>Timeframe</u> Immediate

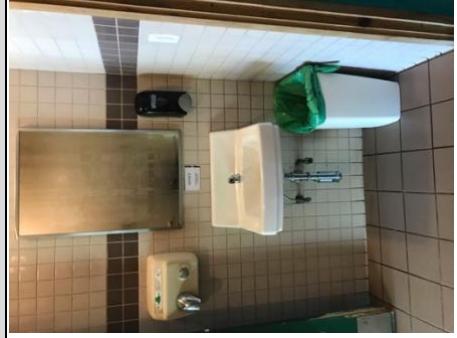
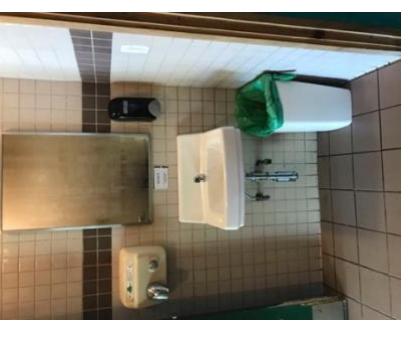
ACAD_Thompson_Picnic_LMK_019

Location: Family Restroom Corrective Action: Wrap pipes under sink			
<u>Deficiency</u> Pipes under sink are exposed.	<u>Solution</u> Wrap the pipes under the sinks in the Restrooms to prevent injury from hot/cold and sharp edges for someone who uses a wheelchair and positions their legs under the sink while washing their hands.	<u>Criticality</u> Critical	<u>Timeframe</u> Immediate
Reference Standards and Guidelines: ABBAS 606.5			
Location: Family Restroom Corrective Action: Lower mirror			
<u>Deficiency</u> The mirror is currently too high at 43.5".	<u>Solution</u> Lower the mirror to 40" above the finish floor.	<u>Criticality</u> Serious	<u>Timeframe</u> Immediate
Reference Standards and Guidelines: ABBAS 603.3
