Acadia National Park

Accessibility Assessment

FINAL REPORT
Findings and Recommendations
DECEMBER 2021

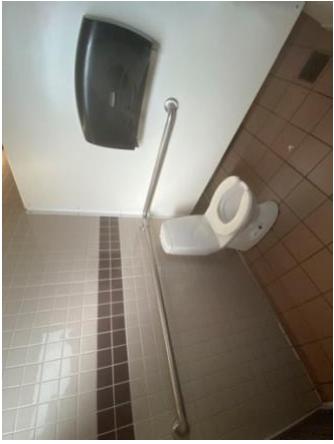
Location: Women's Restroom Corrective Action: Re-install grab bars and toilet paper dispenser			
<u>Deficiency</u>	<u>Solution</u>	<u>Criticality</u>	<u>Timeframe</u>
Grab bars are incorrectly installed.	<p>Flip and reinstall grab bars so the side wall grab bar is 42" long minimum, located 12" maximum from the rear wall and extending 54" minimum from the rear wall and the rear wall grab bar is 36" long minimum and extend from the centerline of the water closet 12" minimum on one side and 24" minimum on the other side.</p> <p>The space between the toilet paper dispenser and grab bars is not sufficient.</p>	<p>serious</p> <p>Immediate</p>	
	<p>Reinstall the toilet paper dispenser 7" minimum and 9" maximum in front of the toilet measured to the centerline of the dispenser. The outlet of the dispenser shall be 15" minimum and 48" maximum above the finish floor and shall not be located behind grab bars.</p>

Reference Standards and Guidelines: ABBAS 604.5.1, 604.5.2, 604.7			
Location: Women's Restroom Corrective Action: Reposition the coat hook and install D ring			
<u>Deficiency</u>	<u>Solution</u>	<u>Criticality</u>	<u>Timeframe</u>
The coat hook is too high at 65.25".	Lower the coat hook to be within reach range at 48" maximum.	<p>serious</p> <p>Immediate</p>	
Door latch on stall is not easily graspable.	Install D-ring handle to inside of stall door.		
Reference Standards and Guidelines: ABBAS 308.2., 309.4

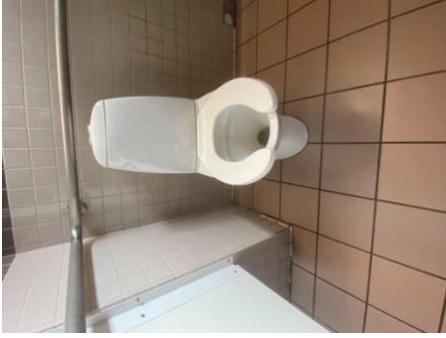
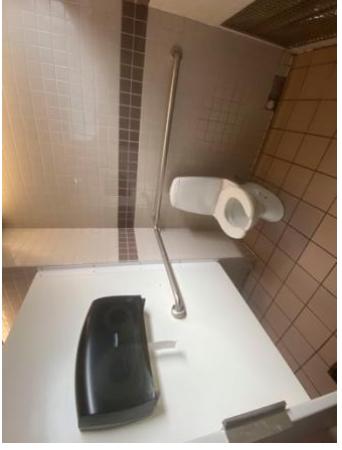
ACAD_Thompson Picnic_LKW_016

Location: Men's Restroom Corrective Action: Re-install grab bars, toilet paper dispenser and sanitary basket		<u>Criticality</u> Serious	<u>Timeframe</u> Short-term
<p>Deficiency Grab bars are incorrectly installed and there is a change in depth of the side wall.</p> <p>Solution Install new side panel to cover entire length of side wall including tiled portion. Flip and reinstall grab bars so the side wall grab bar is 42" long minimum, located 12" maximum from the rear wall and extending 54" minimum from the rear wall and the rear wall grab bar is 36" long minimum and extend from the centerline of the water closet 12" minimum on one side and 24" minimum on the other side.</p> <p>The space between the toilet paper dispenser and grab bars is not sufficient.</p>

Reference Standards and Guidelines: ABBAS 604.5.1, 604.5.2, 604.7, 609.3

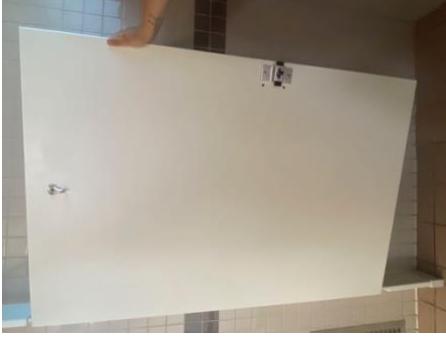
Location: Men's Restroom Corrective Action: Reposition the coat hook and install D ring

Criticality Serious	Timeframe Immediate
Deficiency	Solution			
The coat hook is too high at 65.5". Door latch on stall is not easily graspable.	Lower the coat hook to be within reach range at 48" maximum. Install D-ring handle to inside of stall door.			
Reference Standards and Guidelines: ABBAS 308.2., 309.4				ACAD_Thompson Picnic_LKW_020

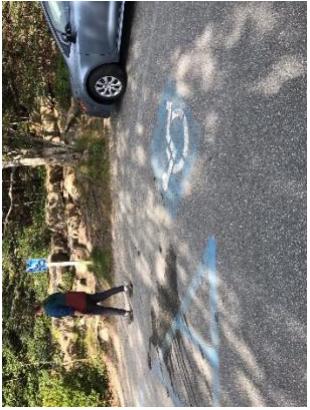
Location: Parking Lot Corrective Action: Rescope and restripe the accessible parking and access aisles

NPS_ACAD_LMNK_	NPS_ACAD_MEC_102
<u>Deficiency</u>	<u>Solution</u>				
Accessible parking spaces are not properly marked for angled parking. Some van accessible spaces do not have an access aisle on the passenger side, which is required for angled spaces.	Maintain angled parking and add access aisles as required. Ensure that aisle is met by a curb cut at the sidewalk. Recommend adding appropriate signage raising the sign marking the van accessible parking space to >60".

Reference Standards and Guidelines: ABAAS 502.3.4, 502.6

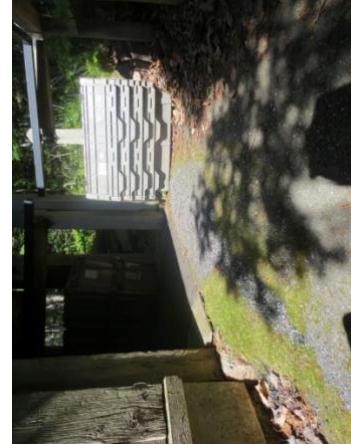
Location: Parking lot – Gift Shop Corrective Action: Improve accessible entrance ramp		Criticality Serious	Timeframe Immediate	NPS_ACAD_MECA_110
Deficiency	Solution			
Current ramp has non-grippable handrail only on one side with open ends. Landing at the rear accessible entrance is not level and ground space is not clear.	Replace handrails with grippable rails that fully return on both ends. Handrails should be on both sides of ramp. Landing at rear entrance should be made level. Implement staff training to ensure route is kept clear of obstructions.

Reference Standards and Guidelines: ABBAS 405.2, 405.3, 405.7, 505

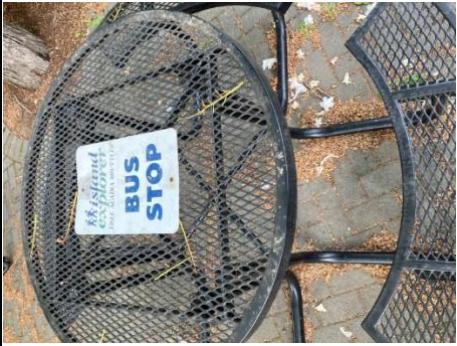
MG_0409.HEIC

<u>Deficiency</u>	<u>Solution</u>	<u>Criticality</u>	<u>Timeframe</u>
There is no sign marking the accessible route and entrance to the Village Green Information Center.	Mark the accessible route from the sidewalk and accessible parking to the entrance of the Village Green Contact Station.	Serious	Immediate
Reference Standards and Guidelines: ABAAS F206; Rehabilitation Act of 1973, as amended, Section 504

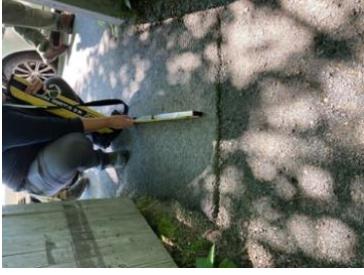
Location: Entrance/Exit Gate	
Corrective Action: Remove slope	
<u>Deficiency</u> Slope at the exit gate to the parking lot is >17% and has a change in level of 1 inch.	<u>Solution</u> Extend the sloped path from the exit gate to lessen the slope.
	<u>Criticality</u> Serious
	<u>Timeframe</u> Short-term

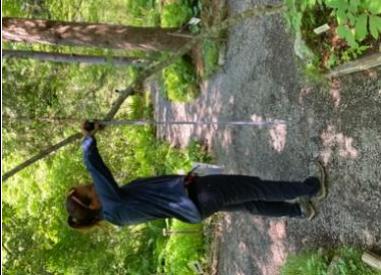
NPS_ACAD_KGP_360	
Reference Standards and Guidelines: ABAAS 303 Changes in Level; 1016 Outdoor Recreation Access Routes	
Location: Garden paths	
Corrective Action: Pruning branches and other vegetation	
<u>Deficiency</u> There are points along the garden paths where branches protrude into the pedestrian route, between 27 and 80 inches.	<u>Solution</u> Prune or train branches out of the paths.
	<u>Criticality</u> Critical
	<u>Timeframe</u> Immediate

NPS_ACAD_KGP_338	
Reference Standards and Guidelines: ABAAS 307 Protruding Objects

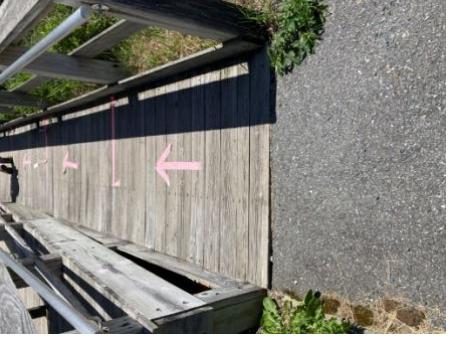
Location: Path from Parking Lot to Main Building Corrective Action: Remove gap between change in surfaces.	Deficiency There is a gap between the paved path from the parking lot to the ramp. Solution Install a transitional plate between the paved path and the ramp to remove the gap in surfaces and improve the accessible route.	Criticality Serious Timeframe Immediate

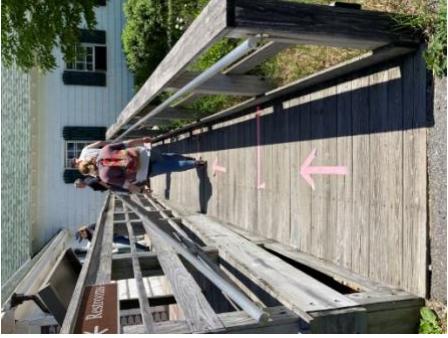
NPS_ACAD_KGP_388

NPS_ACAD_KGP_389	
Reference Standards and Guidelines: ABAAS 302.3, 303	Location: Main Building - Ramp Corrective Action: Extend bilateral hand railings at the top and bottom of the ramp	Deficiency The ramp's bilateral handrails do not extend far enough at the top and bottom of the ramp. Solution Extending the ramp's hand rails bilaterally by a minimum of 12" in the same direction of travel at the top and bottom of the ramp.	Criticality Serious Timeframe Short-term

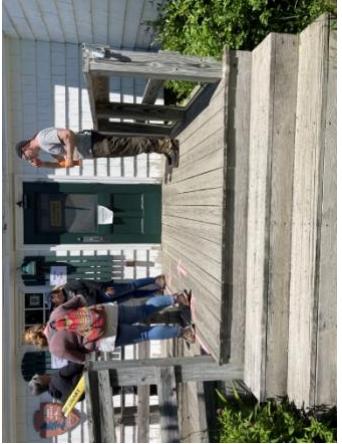
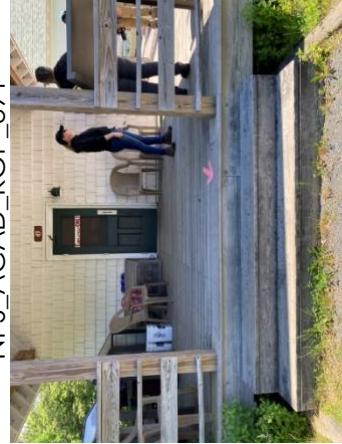
Location: Main Building – front and side steps Corrective Action: Rebuild steps and add railings

NPS_ACAD_KGP_391	NPS_ACAD_KGP_398
<u>Deficiency</u> The front and side steps do not have uniform height and depth and they do not have handrails.	<u>Solution</u> Rebuild the front and side steps with a uniform height between 4"-7" and a uniform depth of 11" and add bilateral handrails to both sets of stairs.	Critical	Short-term

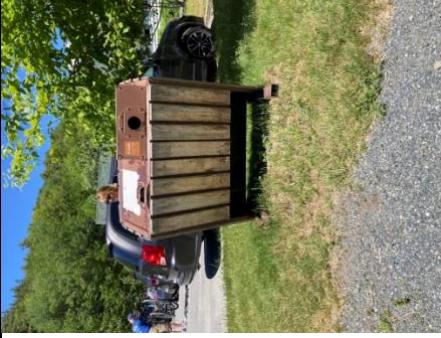
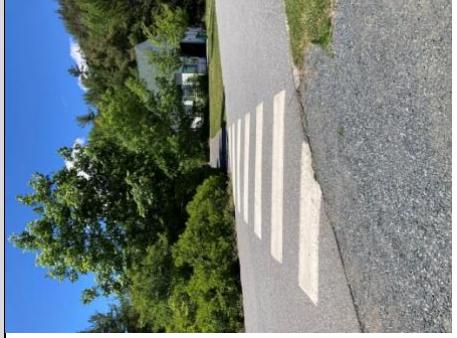
NPS_ACAD_KGP_435

Location: Van Accessible Parking Space (in front of ramp) Corrective Action: Replace and raise sign			
<u>Deficiency</u> The van-accessible parking space is not identified correctly, and the sign is too low.	<u>Solution</u> Improve accessible parking by identifying the accessible parking space closest to the ramp with the International Symbol of Accessibility and the designation "van accessible" on a sign that is a minimum of 60" above the ground to the bottom of the sign.	<u>Criticality</u> Serious	<u>Timeframe</u> Short-term
Reference Standards and Guidelines: ABAAS 502.6, 703.7.2.1			NPS_ACAD_KGP_445
Location: Packed gravel paths outside main building Corrective Action: Trim back vegetation			
<u>Deficiency</u> The vegetation is overgrown at some areas of the gravel paths outside of the main building making the accessible routes too narrow.	<u>Solution</u> Trim overgrown vegetation to ensure packed gravel paths are a minimum of 36" wide (paths may be reduced to 32" for a length of 24", but these reductions must be separated by segments that are a minimum of 48" long and 36" wide).	<u>Criticality</u> Critical	<u>Timeframe</u> Immediate

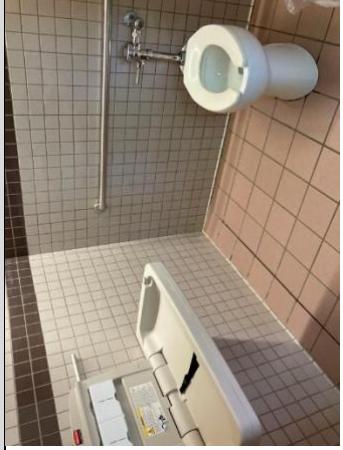
NPS_ACAD_KGP_452

Location: Men's and Women's Restrooms Corrective Action: Lower the baby changing station			
<u>Deficiency</u> The baby changing station is too high outside of reach range.	<u>Solution</u> Lower the baby changing station so that the height of the opening mechanism is <48" to be within reach range.	<u>Criticality</u> Serious	<u>Timeframe</u> Short-term
Reference Standards and Guidelines: ABAAS 308			
Location: Men's and Women's Restrooms Corrective Action: Reorient the grab bars in the accessible stall.			
<u>Deficiency</u> The grab bars are not oriented correctly in the accessible stalls of the men's and women's restrooms.	<u>Solution</u> Flip grab bar around to orient the long end along the sidewalk and the shorter end around the long wall. (The side wall grab bar shall be 42" long minimum, located 12" maximum from the rear wall and extending 54" minimum from the rear wall. The rear wall grab bar shall be 36" long minimum and extend from the centerline of the water closet 12" minimum on one side and 24" minimum on the other side.)	<u>Criticality</u> Serious	<u>Timeframe</u> Immediate
