Lincoln Home National Historic Site

Accessibility Assessment

FINAL REPORT

Findings and Recommendations

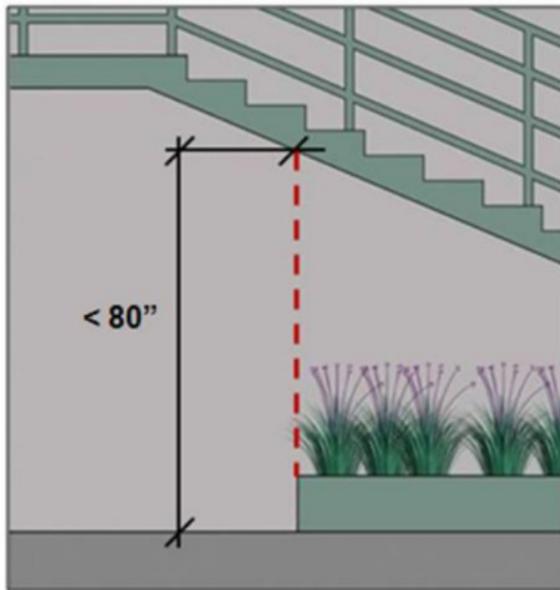
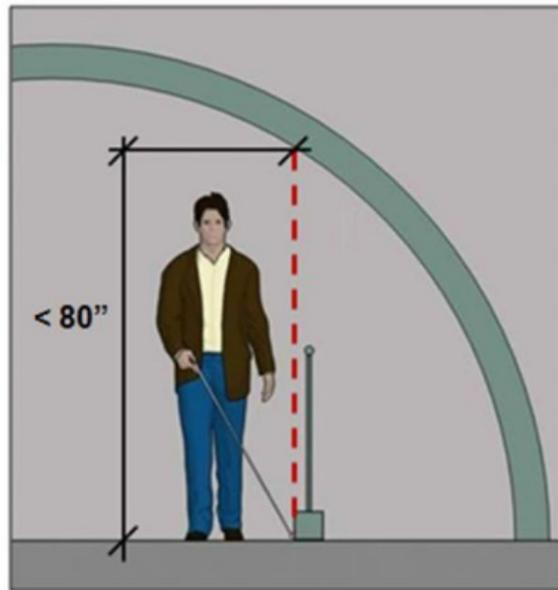
step up and down off the curb can travel along the boardwalk until they reach the fence gate with the international symbol of accessibility. Visitor who use wheelchairs, or who cannot step up or down off the curb, must travel down E Jackson St. until they reach the alleyway behind the Arnold property where they can transition up onto the boardwalk and backtrack to the fence gate. Once visitors have arrived at the back of Arnold House, they have the option to use a ramp or stairs to reach the exhibit entrance. Several of the boardwalk planks in this area require maintenance or replacement. To the right of the ramp and stairs the roof slopes down to provide cover over a porch area. The sloped roof is only 2" away from the boardwalk that leads to the entrance stairs and is a potential hazard.

Recommendations #2: The sloped roof that hangs over the porch area is 63" above the ground floor. The lack of 80" of vertical clearance qualifies the roof as a protruding object. Place a fixed barrier such as planters or benches where the vertical clearance is less than 80". Ensure the barriers have a leading edge no more than 27" high so that they are cane detectable.

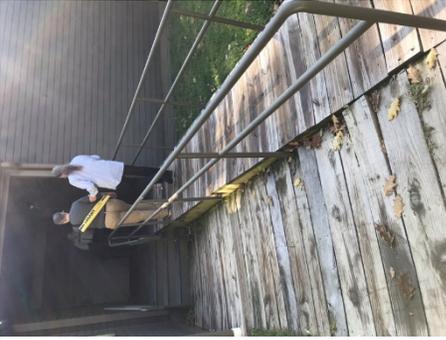
<p>Location: Corneau House Corrective Action: Relocate safety cabinet</p>			
<p><u>Deficiency</u> The yellow safety cabinet located below the fire alarm pull is creating an obstruction.</p>	<p><u>Solution</u> Relocate the safety cabinet to create unobstructed reach range for the fire alarm pull.</p>	<p><u>Criticality</u> Critical</p> <p><u>Timeframe</u> Immediate</p>

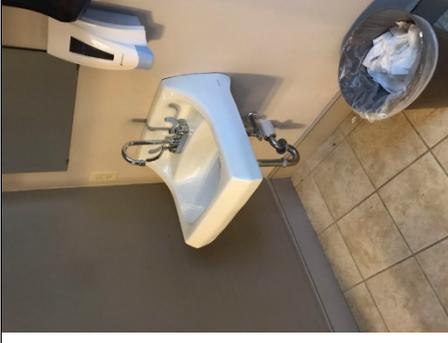
LHO_Staff Offices_LMK_136

Deficiency
Pipes under the sink are exposed.

Criticality
Critical

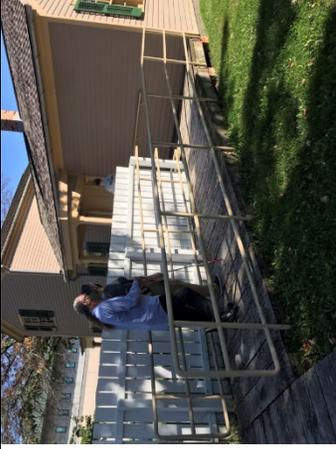
<p>Location: Morse House Corrective Action: Add edge protection to ramp</p>			
<p><u>Deficiency</u> The ramp leading to the entrance does not have edge protection.</p>	<p><u>Solution</u> Add edge protection along each side of the ramp. If a curb is used to provide edge protection, it must be at least 4" high.</p>	<p><u>Criticality</u> Serious</p> <p><u>Timeframe</u> Short-term</p>

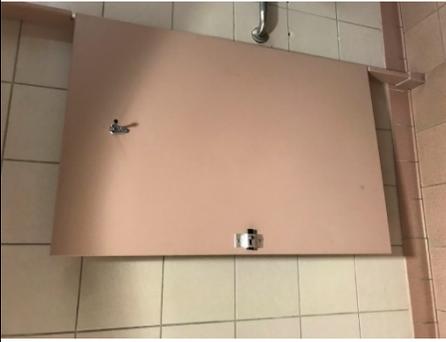
<p>LHO_Visitor Center_LMK_173</p>

<p>LHO_Visitor Center_LMK_154</p>
<p>Reference Standards and Guidelines: ABAAS 308.2</p>			
<p>Location: Men's and Women's restrooms</p> <p>Corrective Action: Lower hook and add D-ring door pull</p>			
<p><u>Deficiency</u> The clothing hook on the back of stall door is too high. Stall door latch is not easily graspable.</p>	<p><u>Solution</u> Lower the clothing hook to be within reach range of 15-48" above the finish floor. Install D-ring door pulls to allow for ease of use.</p>	<p><u>Criticality</u> Serious</p> <p><u>Timeframe</u> Short-term</p>

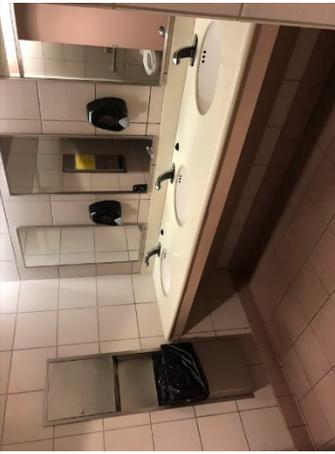
<p>Location: Men's restroom Corrective Action: Increase water run time</p>			
<p><u>Deficiency</u> Sink faucet does not run long enough.</p>		<p><u>Criticality</u> Serious</p> <p><u>Timeframe</u> Short-term</p>

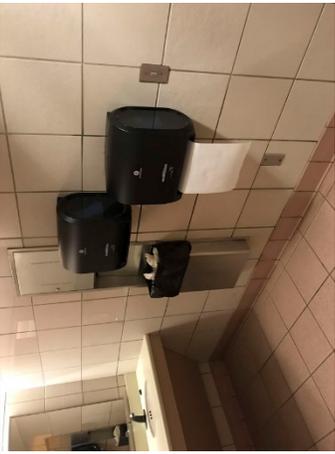
<p style="text-align: right;">LIHO_Visitor Center_LMK_168</p>
<p>Reference Standards and Guidelines: ABAAS 606.4</p>			
<p>Location: Men's restroom Corrective Action: Place permanent object below paper towel dispensers</p>			
<p><u>Deficiency</u> The wall mounted paper towel dispensers are protruding objects.</p>	<p><u>Solution</u> Place a permanent or semi-permanent object or structure beneath the paper towel dispensers to be in detectable range of a white cane, 0-27" above the finished floor.</p>	<p><u>Criticality</u> Serious</p> <p><u>Timeframe</u> Immediate</p>

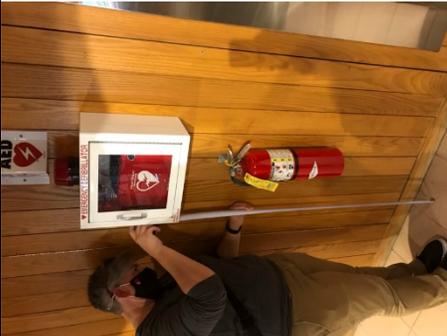
<p>Location: Restroom alcove Corrective Action: Place permanent object below defibrillator</p>			
<p><u>Deficiency</u> The defibrillator located on the wall inside the restroom alcove is a protruding object.</p>	<p><u>Solution</u> Place a permanent object or structure beneath the defibrillator to be in detectable range of a white cane. Consider placing a box around the fire extinguisher that is hanging beneath the defibrillator to create a cane detectable object (0-27" above the finished floor).</p>	<p><u>Criticality</u> Critical</p> <p><u>Timeframe</u> Immediate</p>

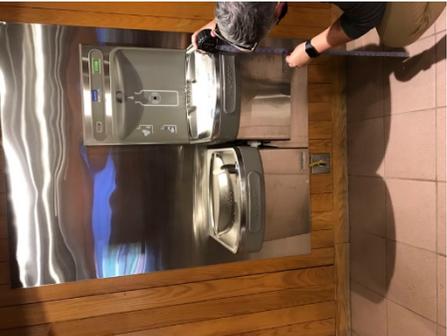
<p>LHO_Visitor Center_LMK_162</p>

<p>LHO_Visitor Center_LMK_164</p>
<p>Reference Standards and Guidelines: ABAAS 307.2</p>			
<p>Location: Restroom alcove Corrective Action: Reinstall or replace the water fountain</p>			
<p><u>Deficiency</u> The tall water fountain is a protruding object.</p>	<p><u>Solution</u> Reinstall the water fountain so that it is recessed and protrudes a maximum of 4" or replace the water fountain with one that does not protrude or is no more than 27" high.</p>	<p><u>Criticality</u> Serious</p> <p><u>Timeframe</u> Short-term</p>

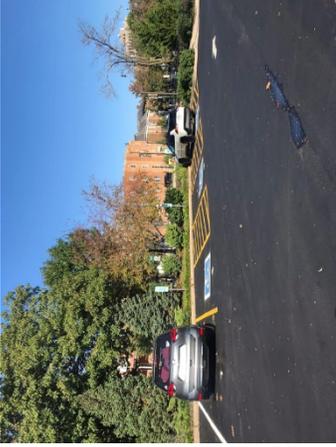
<p>Location: Visitor Parking lot Corrective Action: Replace accessible parking signs</p>			
<p><u>Deficiency</u> Signs indicating accessible parking are too low. No parking is designated as "van accessible".</p>	<p><u>Solution</u> Replace existing signs and poles so that signs are 60" high minimum. Ensure at least one sign indicates "van accessible".</p>	<p><u>Criticality</u> Critical</p> <p><u>Timeframe</u> Immediate</p>

Recommendation #1: Replace the parking sign for space 9 and/or 10 to indicate "Van Accessible" parking and ensure it is 60" high measured to the bottom edge.

Recommendation #2: Replace remaining accessible parking space signs so that they measure 60" high to the bottom edge.

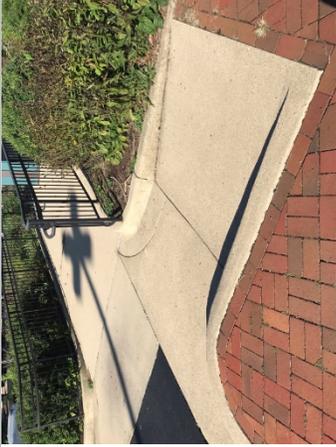
<p>LIHO_Circulation Path_LMK_194</p>
<p>Reference Standards and Guidelines: ABAAS 405.2, 406.1</p>

<p>LIHO_Circulation Path_LMK_188</p>
<p>Reference Standards and Guidelines: ABAAS 502.6</p>			
<p>Location: Visitor Parking lot Corrective Action: Regrade/extend curb ramp</p>			
<p><u>Deficiency</u> Curb ramp leading from parking lot to sidewalk has 12.5% slope.</p>	<p><u>Solution</u> Extend curb ramp to 109" to ensure appropriate slope.</p>	<p><u>Criticality</u> Serious</p> <p><u>Timeframe</u> Mid-term</p>

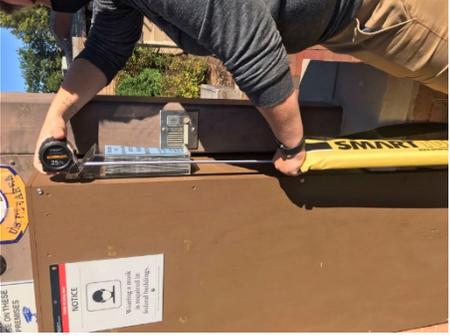
<p>Location: Visitor Parking lot Corrective Action: Lower the park brochure holder</p>			
<p><u>Deficiency</u> Park brochure holder attached to bulletin board structure is out of reach range.</p>	<p><u>Solution</u> Lower the brochure holder so that is it no higher than 48" maximum to the highest operable part or outlet.</p>	<p><u>Criticality</u> Critical</p> <p><u>Timeframe</u> Immediate</p>

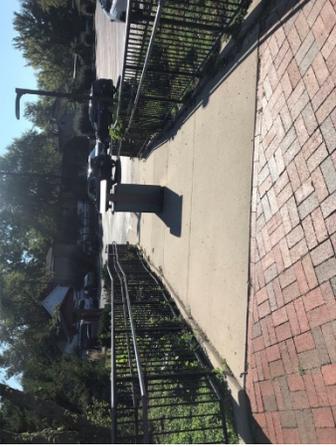
<p>LIHO_Circulation Path_LMK_204</p>
<p>Reference Standards and Guidelines: ABAAS 405.2</p>

<p>LIHO_Circulation Path_LMK_196</p>
<p>Reference Standards and Guidelines: ABAAS 308.2.1</p>			
<p>Location: Visitor Parking Lot Corrective Action: Regrade accessible route ramp</p>			
<p><u>Deficiency</u> Accessible route ramp has slope up to 9.7%.</p>	<p><u>Solution</u> Regrade the ramp so that it does not exceed 8.3%.</p>	<p><u>Criticality</u> Serious</p> <p><u>Timeframe</u> Long-term</p>

Recommendation #5: Regrade accessible route ramp when entire path is renovated so that slope does not exceed 8.33%.

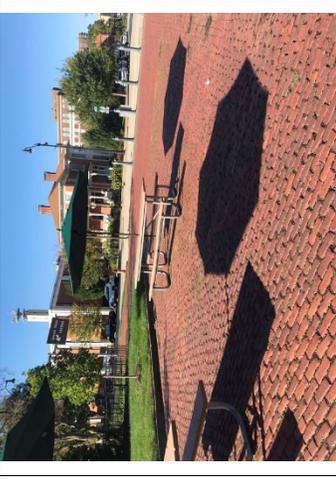
<p>LIHO_Circulation Path_LMK_211</p>
--	---	--	--

<p><u>Deficiency</u> None of the six picnic tables are accessible.</p>	<p><u>Solution</u> Replace at least two of the picnic tables with accessible picnic tables. Ensure tables have appropriate clear ground space of 36" on all sides. Alternatively, replace all picnic tables with accessible versions to meet universal design principles.</p>	<p><u>Criticality</u> Critical</p> <p><u>Timeframe</u> Immediate</p>

Corrective Action: Replace picnic tables

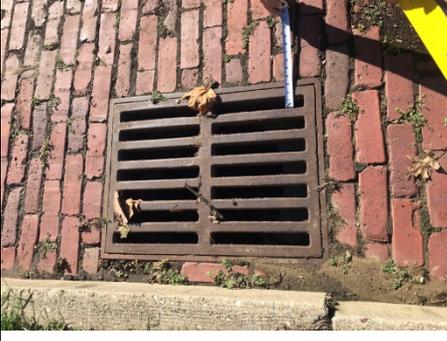
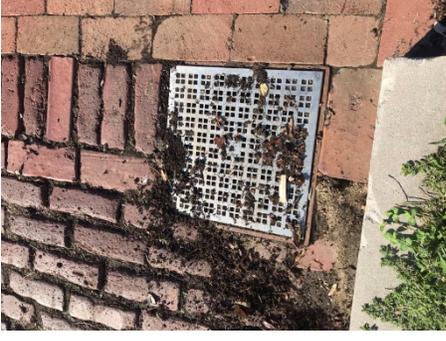
Location: Jackson St. Picnic Area
Corrective Action: Replace grates

Deficiency

Recommendation #8: Replace the two grates that have 1.25" openings with a version that has openings no larger than ½".

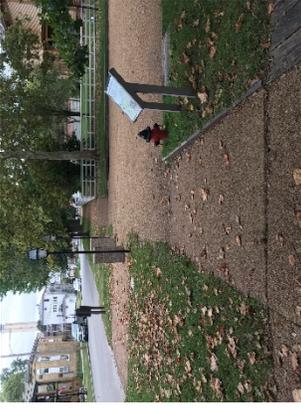
<p>LIHO_Circulation Path_LMK_238</p>
--	---	---	--

**Location: Pedestrian Entrance at Eighth St. and E Edwards St.
Corrective Action: Relocate wayside**

<p><u>Deficiency</u> The orientation wayside at this intersection is located on a curb ramp.</p>	<p><u>Solution</u> Relocate the wayside to an area with level surface ground. Recommend relocating to the street level where pedestrians first enter the site. A level clear ground space measuring 36x48" should be positioned in front of the wayside, centered on the interpretive information, for either a forward or parallel approach.</p>	<p><u>Criticality</u> Serious</p> <p><u>Timeframe</u> Immediate</p>

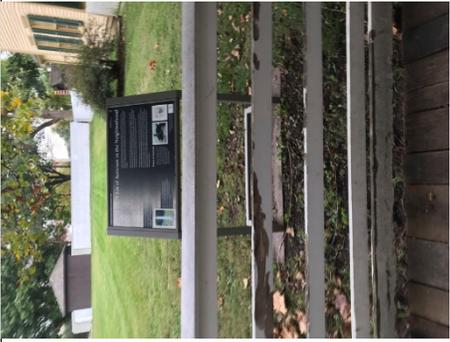
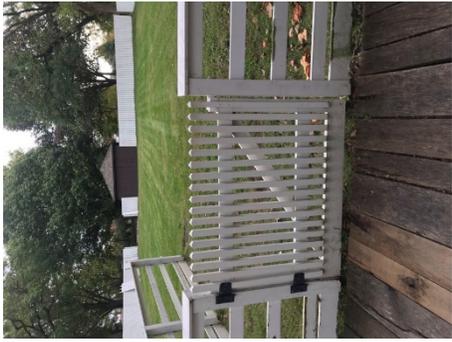
<p><u>Deficiency</u> The fence in front of the wayside is 42.75" high and blocks the view for individuals with short stature or those using a wheelchair.</p>	<p><u>Solution</u> Relocate the wayside to the section of the fence that has a gated entrance. Remove the gate entirely and place the wayside in the threshold to block visitors from entering the yard.</p>	<p><u>Criticality</u> Serious</p> <p><u>Timeframe</u> Short-term</p>

Corrective Action: Relocate wayside

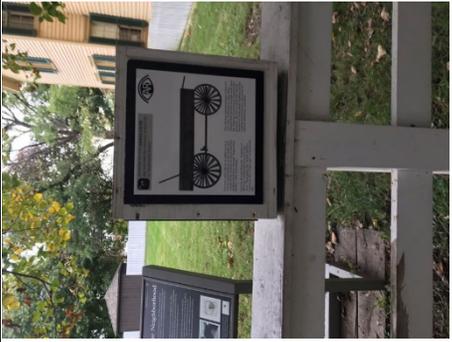
<p>LIHO_Circulation Path_LMK_242</p>
--	---	--	--

**Location: Jenkins Lot Augmented Reality
Corrective Action: Implement tactile model**

<p><u>Deficiency</u> The augmented reality exhibit is solely visual without other ways for visitors to interact with it.</p>	<p><u>Solution</u> Enhance the ability for visitors to interact with the exhibit by providing a tactile model of the wagon.</p>	<p><u>Criticality</u> Serious</p> <p><u>Timeframe</u> Short-term</p>

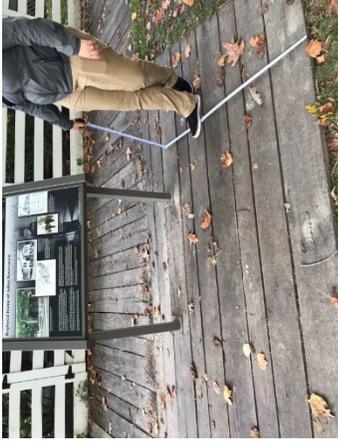
LIHO_Circulation Path_LMK_261

<p><u>Deficiency</u> The wayside panel is worn and not readable. The lower viewfinder cannot be accessed by a wheelchair user.</p>	<p><u>Solution</u> Reprint the wayside panel so that all the text is readable. Reposition the lower viewfinder so that there is an unobstructed approach and sufficient maneuvering clearance.</p>	<p><u>Criticality</u> Minor</p> <p><u>Timeframe</u> Short-term</p>

Location: "Lincoln's Home Becomes a Shrine" wayside
Corrective Action: Redesign and reposition wayside
